Inspection Report

Historic Sample

Property Address:
10 Sample Rd
Sample MA

Omega Home Inspections, LLC

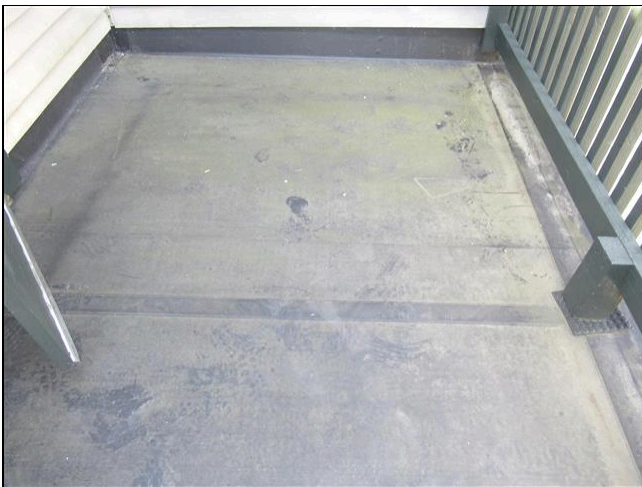
1.0 (2) The flat roof at the second floor, left side was covered with a rubber membrane. Rubber membrane is a quality roof covering that usually lasts 20-30 years if properly maintained. This roof appeared to be approximately 15 years old. It is important that the seams between the sections of rubber stay sealed. I recommend that every couple of years the roof be inspected.

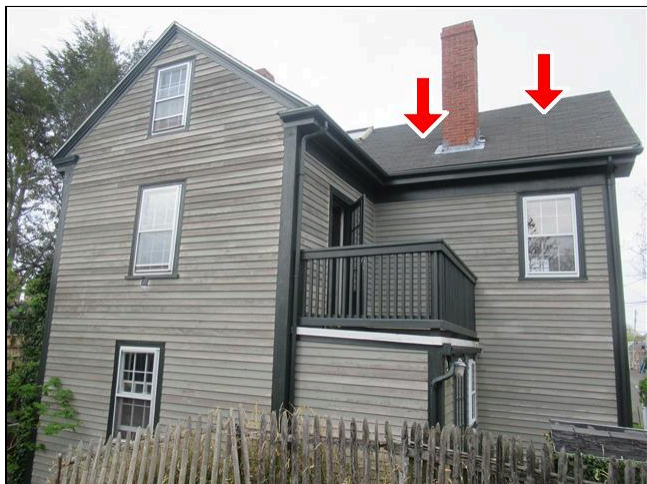
1.0 (3) There were missing asphalt shingles at the left side of the roof. I recommend that a licensed roofer repair the damaged areas.

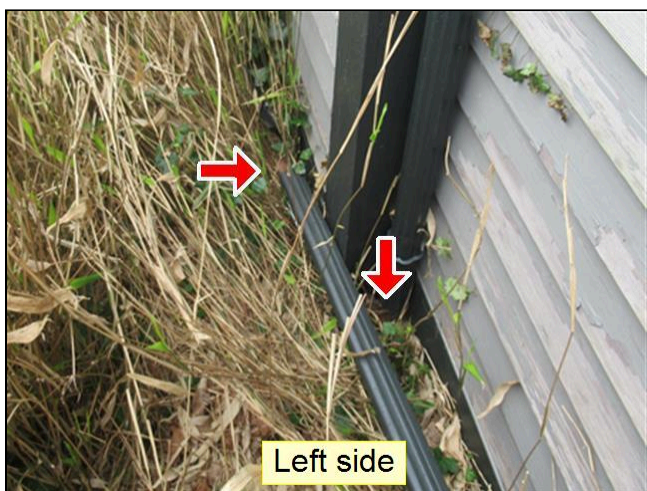
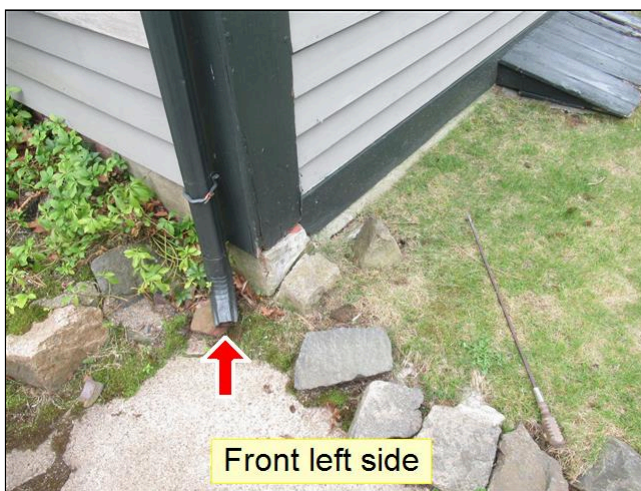
1.3 (1) There were missing downspout extensions. Downspouts carry roof water to the ground and should have extensions that direct the water to an appropriate distance, 5 or 6 feet, from the foundation. If there are no downspout extensions, or if the extensions are too short, the roof water may eventually end up in the basement. I recommend that downspout extensions be installed to carry the water to an appropriate distance from the house.

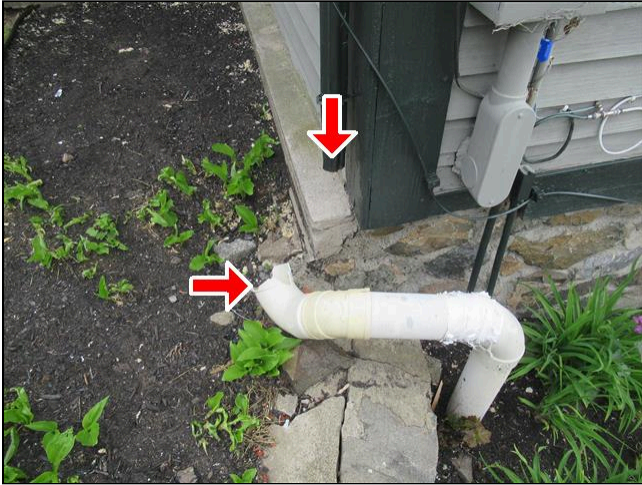
1.3 (2) The gutter downspout at the right corner of the house discharged into underground drain. The portion of the pvc drain above ground was damaged and not connected to the downspout. I recommend this portion of the drain pipe be repaired. I also recommend obtaining information from the seller as to where the drain terminate, in case the drain becomes blocked and needs to be unclogged. I recommend testing operation of the drain to ensure that it is not clogged (by checking the drain during heavy rain or with a garden hose).

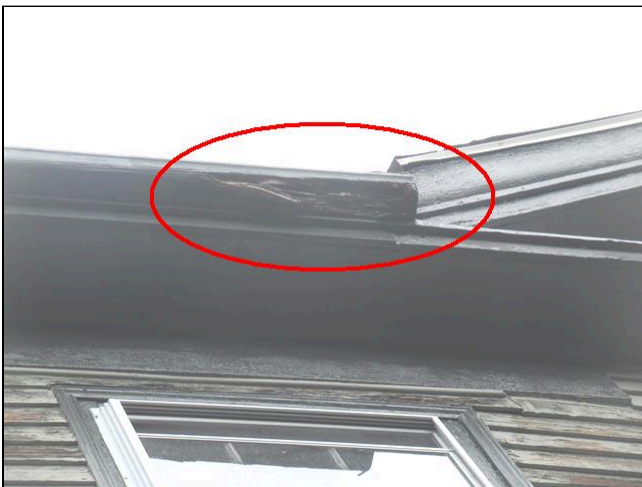
1.3 (4) The wood gutter at the rear of the building was decayed. I recommend a licensed contractor with wood gutter experience repair this gutter.

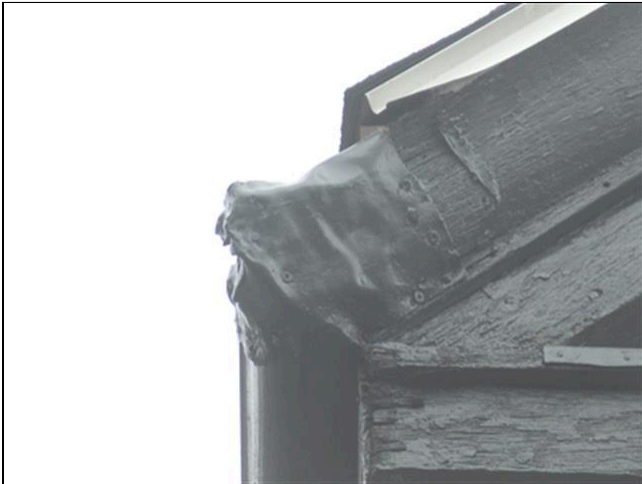
1.3 (5) Several of the wood gutters had been repaired with metal flashing. I would verify if the repairs are not leaking when it rains.

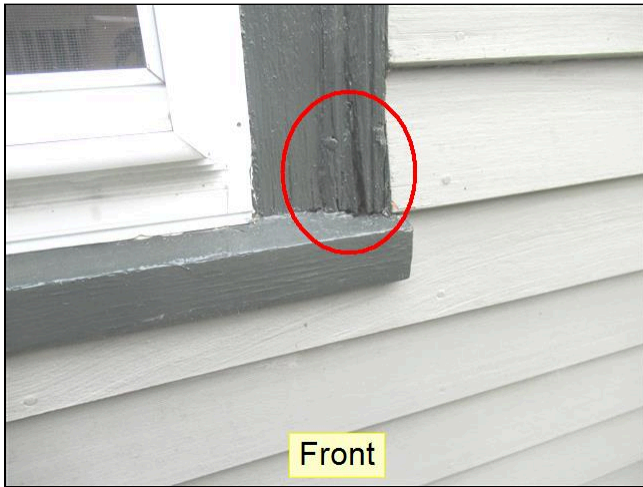
2.0 (2) There was decayed window and door trim at various areas around the house. There is a potential for concealed damage behind the decayed areas. I recommend that a qualified contractor remove and replace all decayed wood prior to painting the building.

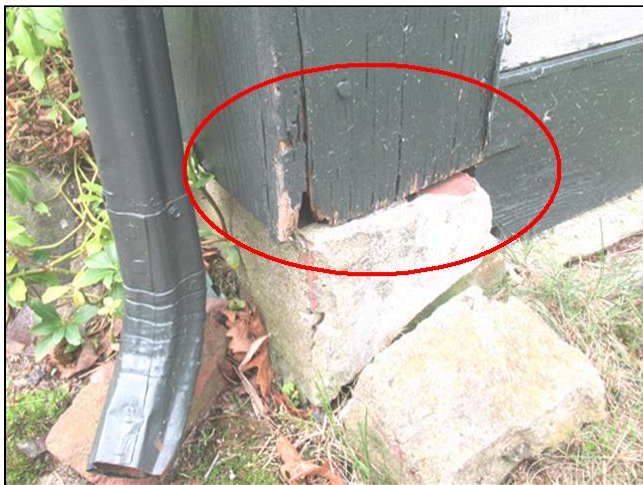
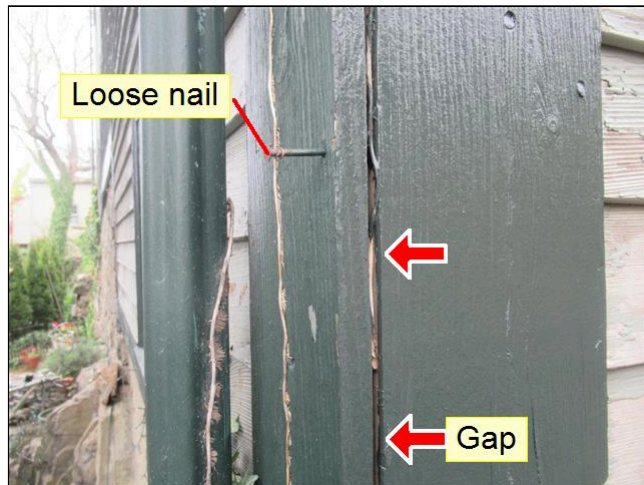
2.0 (3) The corner board trim was decayed at the left front corner of the house. There is a potential for concealed damage behind the corner board. I recommend that this area be further inspected by a licensed contractor and repaired as needed. I also recommend the left rear corner board be secured where it's loose and any remaining gaps be caulked.

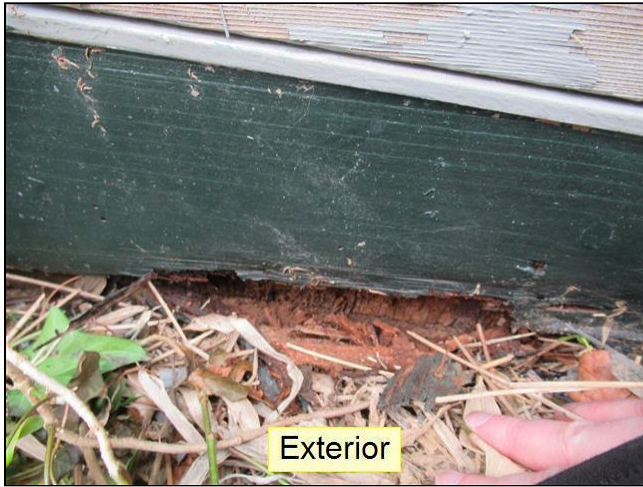
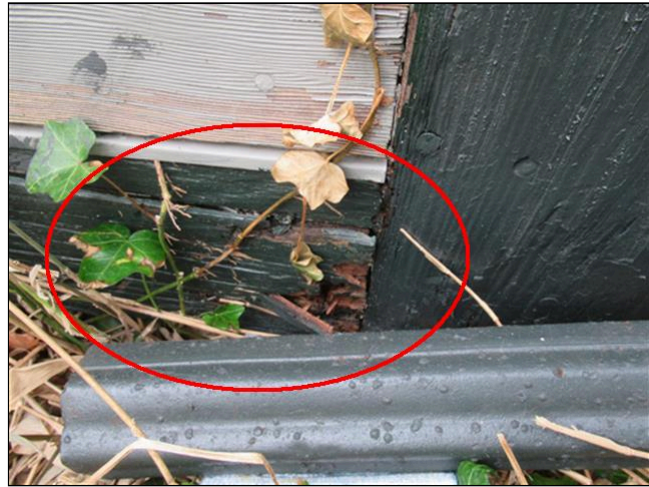
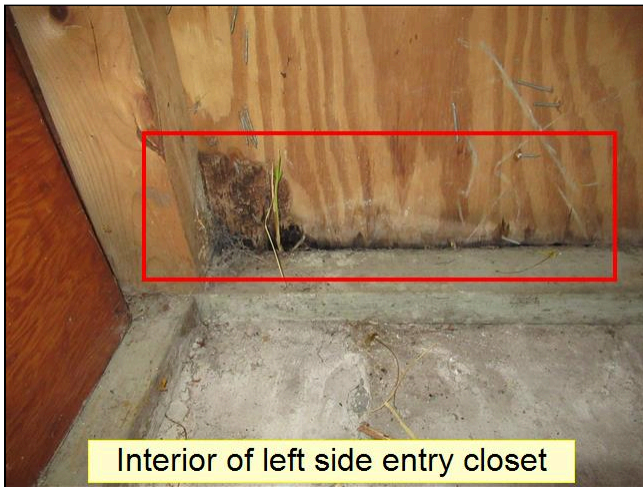
2.0 (4) The wood trim was decayed where it was in contact with the soil at the left side of the house. Wood in contact with soil decays and is easy access for wood destroying insects. There is the potential for further damage behind the trim and siding. I recommend a qualified carpenter replace the trim and further investigate the structure behind it. I also recommend that the earth be cleared away from this area. If found to be difficult due to grading, planting beds etc. plastic or cement based trim can be used that will not deteriorate as readily when in contact with soil.

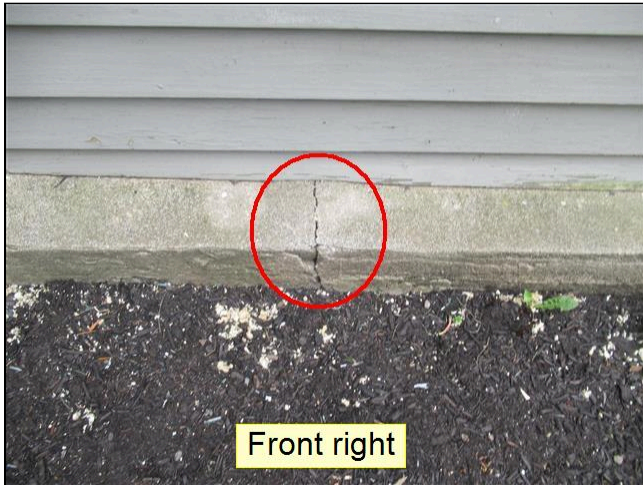
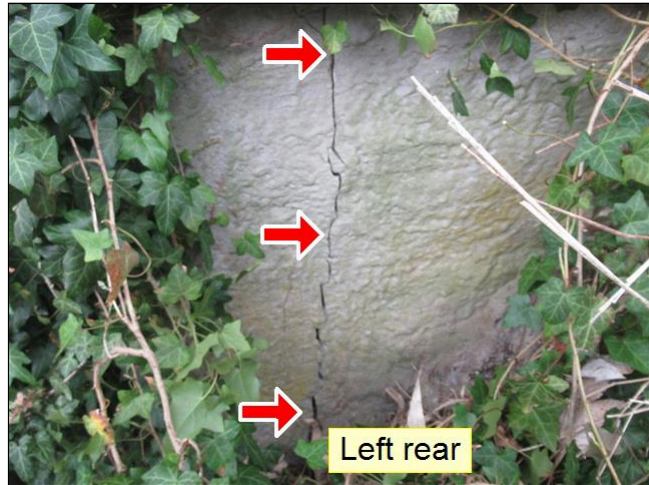
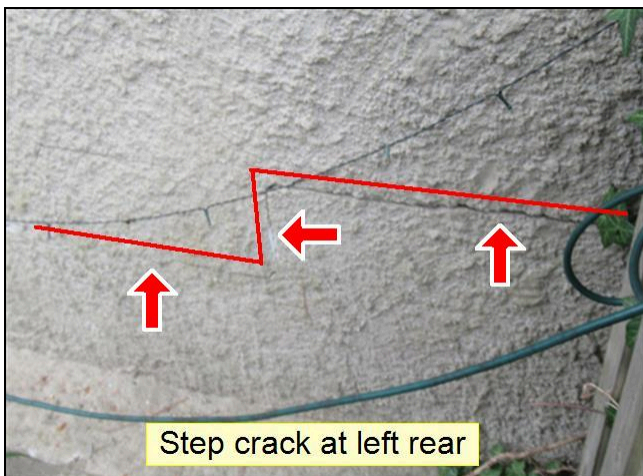
2.2 There were several cracks in the exterior foundation walls. The cracks at the left rear appear to be in the parge coat. (A parge coat is a thin layer of concrete applied over masonry.) This portion of the foundation may be cement blocks based on the step cracking in the parge coat. I recommend that the cracks be repaired by a qualified mason and that the cracks be monitored for further movement.

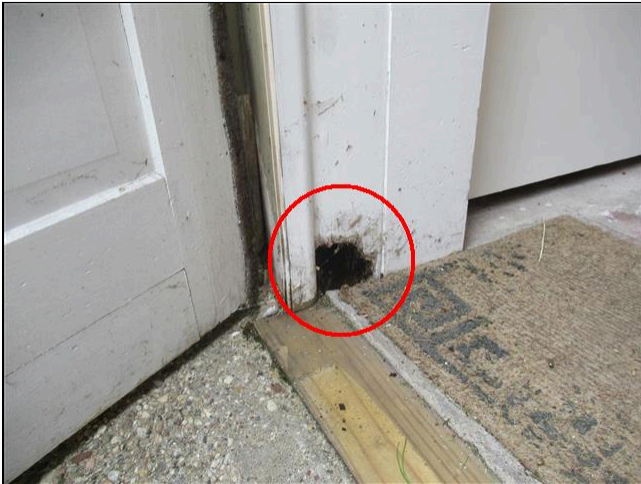
2.3 (1) There was decay in the door jamb at the left front side of the house. I recommend that a qualified carpenter repair or replace this door jamb.

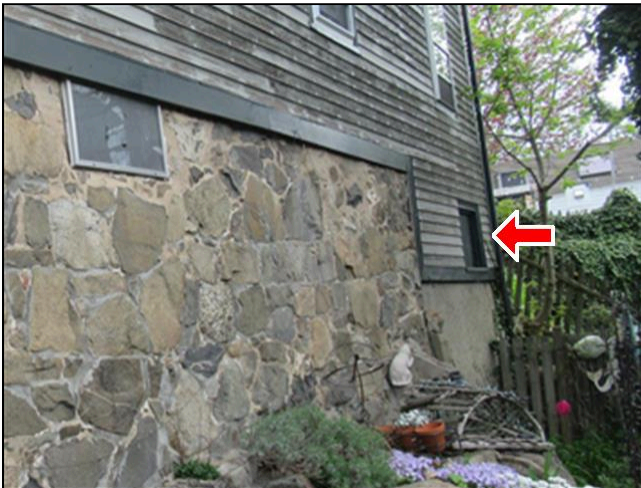
2.3 (2) There was an access door at the left rear wall of the house. The door was painted shut and could not be opened at the time of the inspection. I recommend that the seller be asked about the space behind the door. This side of the house may have been a later addition with this door being the access point to the area/ crawlspace beneath it. If you end up purchasing the house, Omega Home Inspections will return to the property, attempt to gain access and inspect the area beneath at no additional charge.

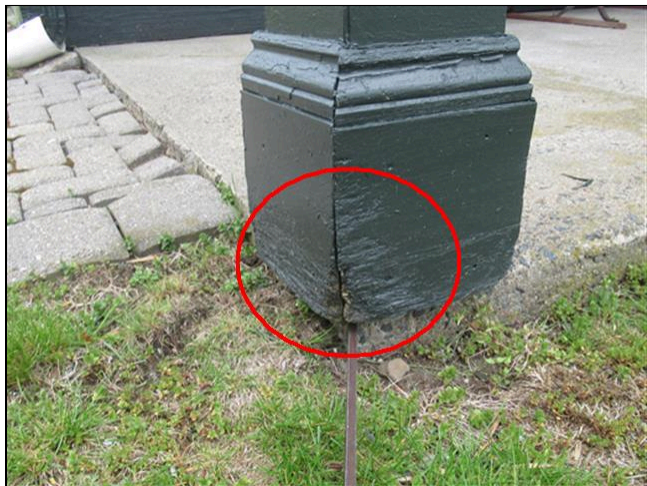
2.6 (1) There was rotted wood trim at the front porch column base. This a structural post that is supporting the porch roof. I recommend that the decayed wood be replaced and that the post behind the decayed wood trim is further inspected by a qualified carpenter.

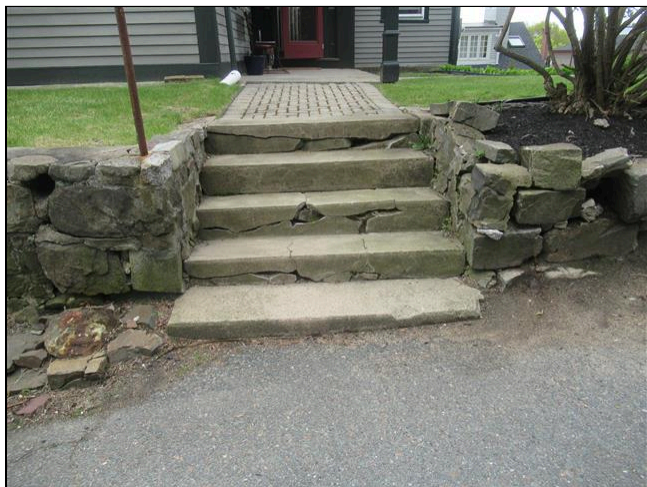
2.6 (2) There was deterioration in the concrete on the steps at the front of the house. Over time, water will penetrate these areas, freeze, and worsen the deterioration. I recommend that a qualified mason repair these steps.

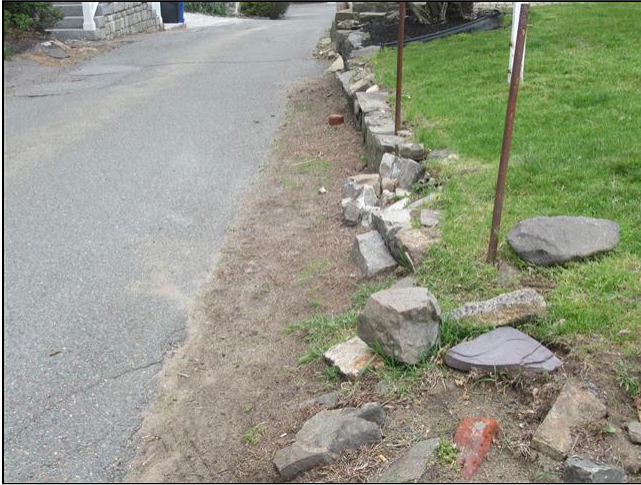
2.9 The retaining wall at the front of the house was falling down. I recommend that a qualified mason repair the wall.

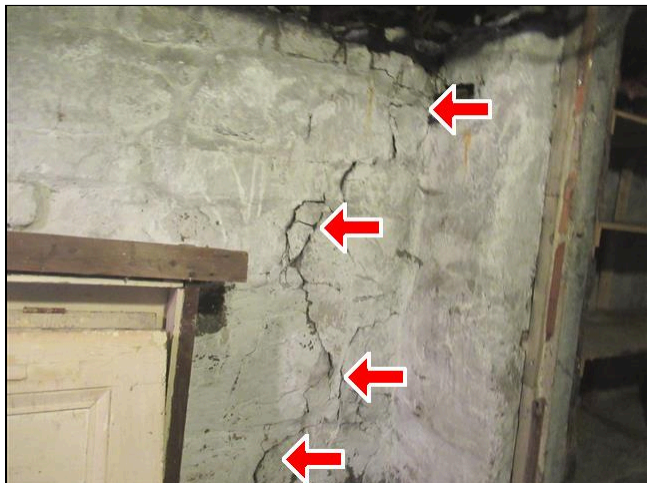
3.0 (2) There was a crack at the rear wall. The crack appeared to be from settlement. I recommend that this crack be repaired by a qualified mason and then monitored for further movement. The masonry at the exterior side of this wall had been repointed.

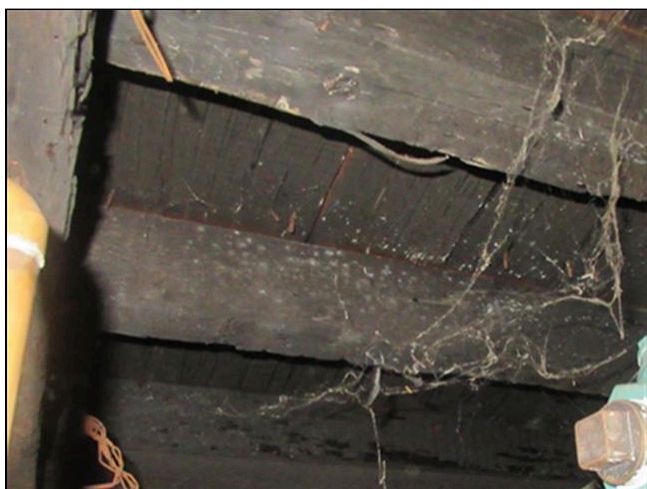
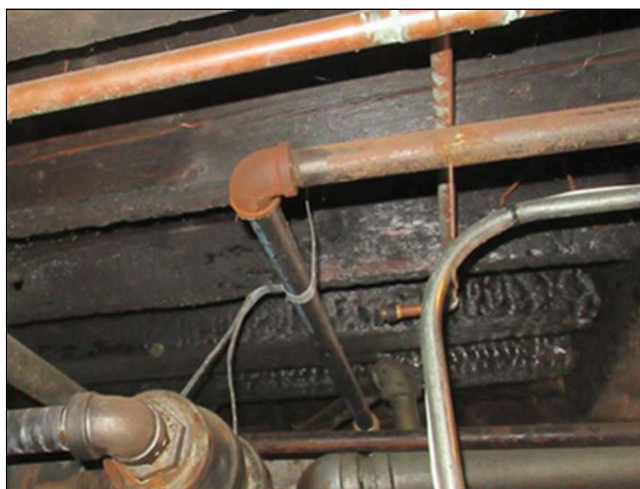
3.0 (5) There was a fire in the basement. There was charred wood above the boiler. I recommend that information be obtained from the seller and or local fire department regarding when the fire occurred and whether all subsequent inspections were done to ascertain whether the wood is still structurally sound.

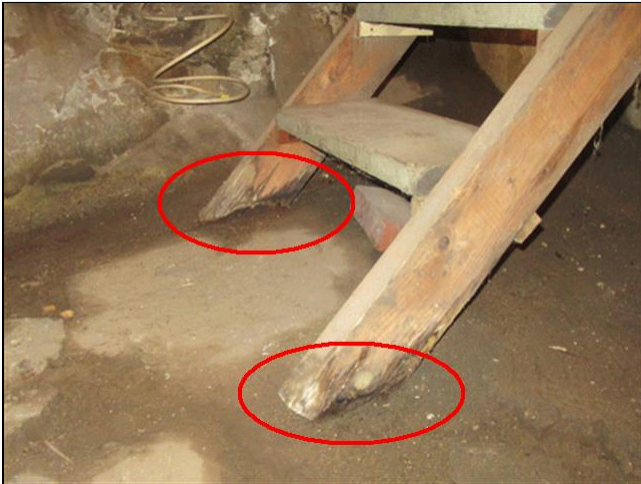
3.0 (6) The basement stair stringers were decayed at the bottom. The stringers are slowly deteriorating. I recommend that the basement stairs be repaired or replaced.

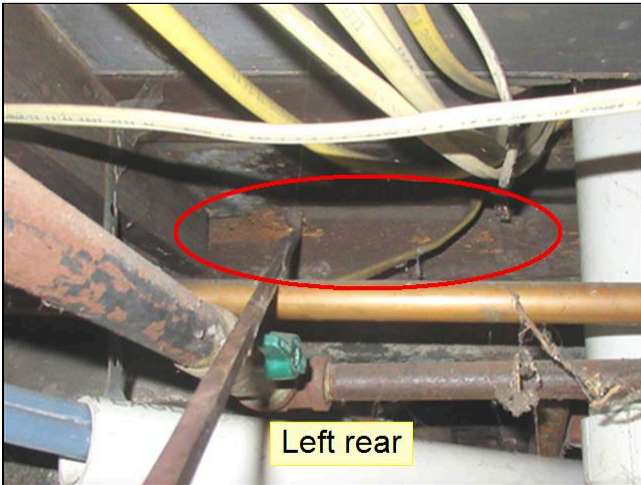
3.1 (1) There were signs of wood destroying insect damage in the sill at the left rear and rear side of the building. Although no active insects were observed, I recommend that a full insect inspection be done by a reputable pest company.

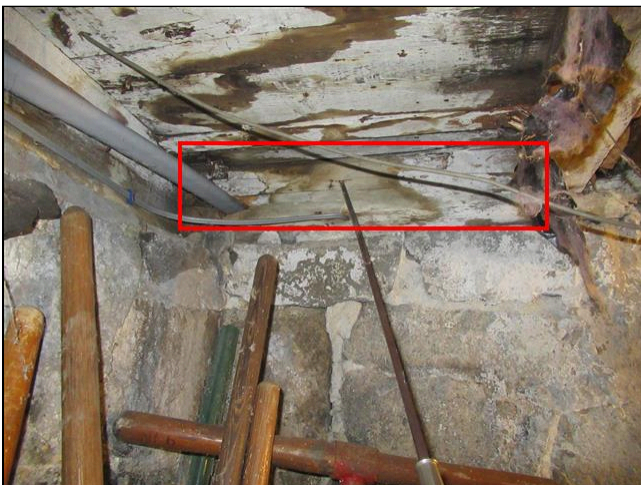
3.1 (2) There was some decay in the sill at the right front side of the building, possibly caused by an old leak. I recommend further investigation by a licensed general contractor with experience in colonial houses.

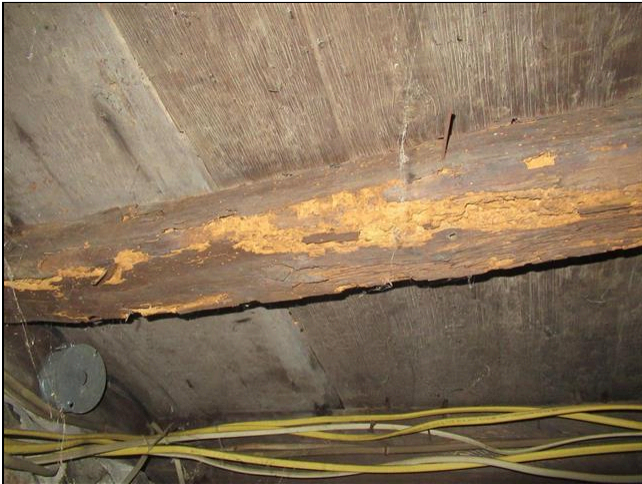
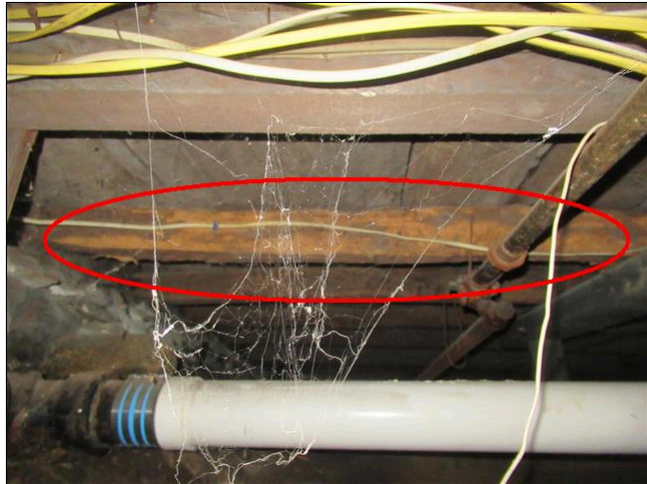
3.2 There was wood destroying insect damage at the basement ceiling/first floor structure. There is the potential for concealed damage in the house. See previous recommendation in note 3.1.

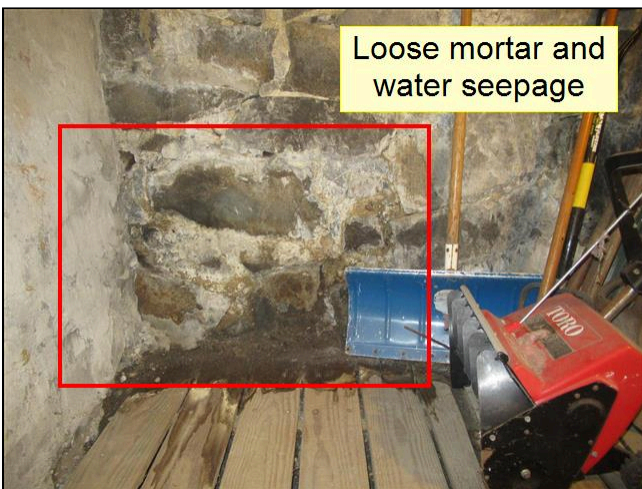
3.3 (1) There were signs of water seepage at the right front basement wall. There was a crack at the exterior of the wall in approximately the same location. See note 2.2. The mortar was also loose at this location and in need of repointing. I recommend that a qualified mason repair these cracks and that they be monitored for further movement. I recommend the interior side of the foundation wall be repointed by the same mason.

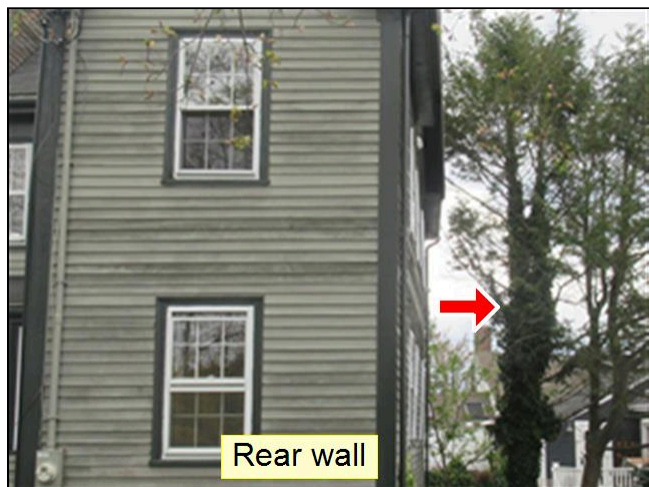
3.3 (2) There was a noticeable bow in the exterior rear wall of the house which is not uncommon in houses of this vintage. That being said, all visible structure and finished walls, ceilings and floors in this area were inspected for cracking and signs of movement. I recommend monitoring the ceilings, walls and floors for cracking in the finishes. If found to be worsening or if you are unsure of it's stability, I recommend that a licensed general contractor with experience in houses of this vintage further investigate the structure. This is for your information.

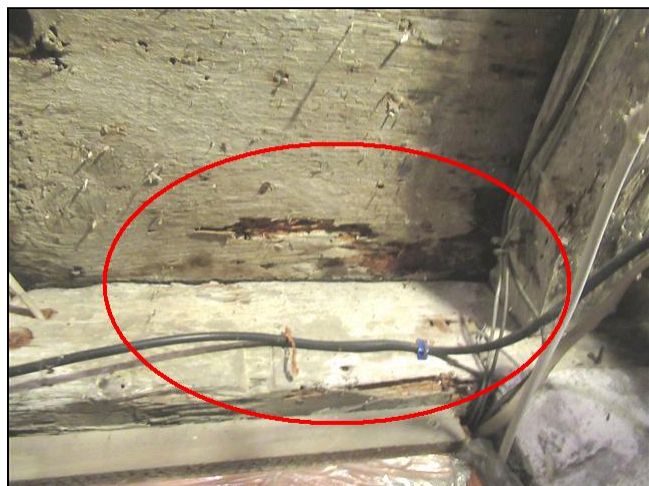
3.4 (1) There was wood destroying insect damage at the first floor sub-floor. There is the potential for concealed damage in the house. See previous recommendation in note 3.1.

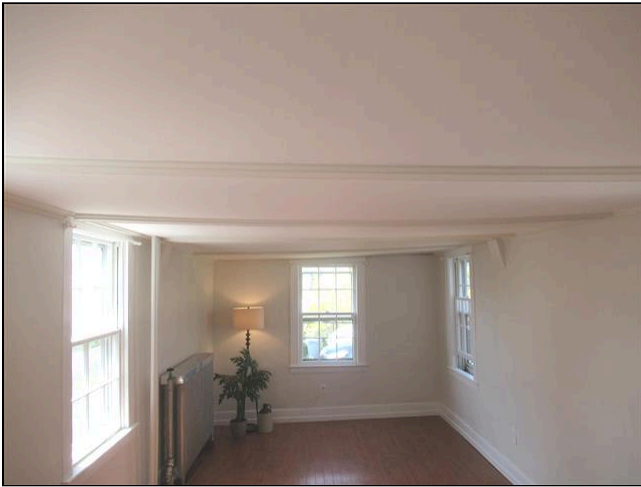
3.6 There was a sag in the living room ceiling which is not uncommon in houses of this vintage. That being said, the ceiling was inspected for cracks which would indicate movement, none were found. I recommend monitoring the ceiling and walls for cracks and the floor above for softness (movement when walked on). If found to be worsening or if you are unsure of it's stability, I recommend that a licensed general contractor with experience in houses of this vintage further investigate the structure. This is for your information.

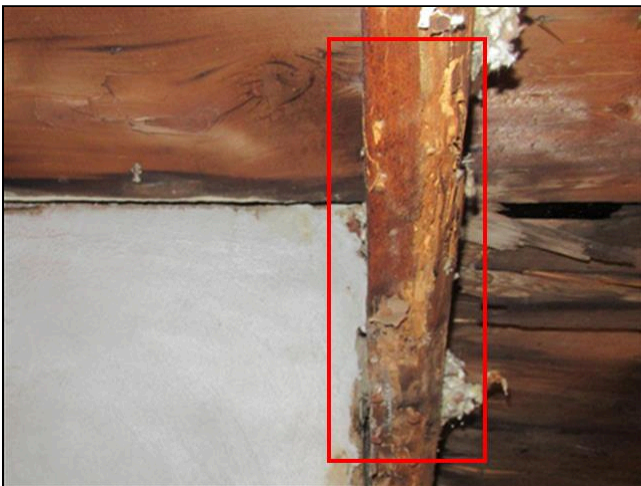
3.7 (1) There were signs of wood destroying insect damage in the roof framing by the chimney. Although no active insects were observed, I recommend that a full insect inspection be done by a reputable pest company.

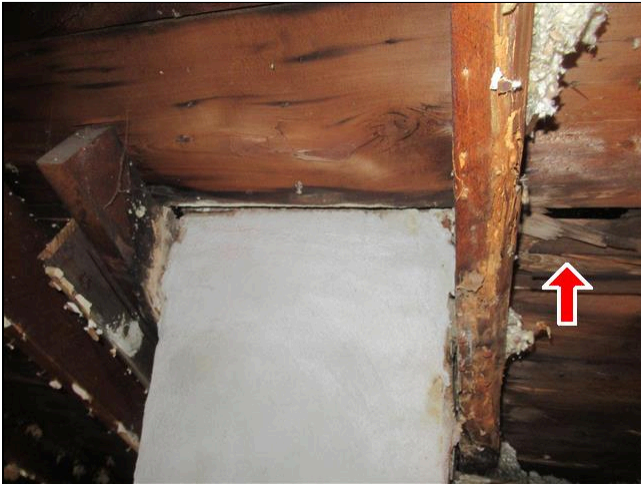
3.7 (2) The roof sheathing was stained at the chimney. I recommend monitoring the area for further deterioration and repair as needed. The flashing at this chimney may have to be sealed or replaced.

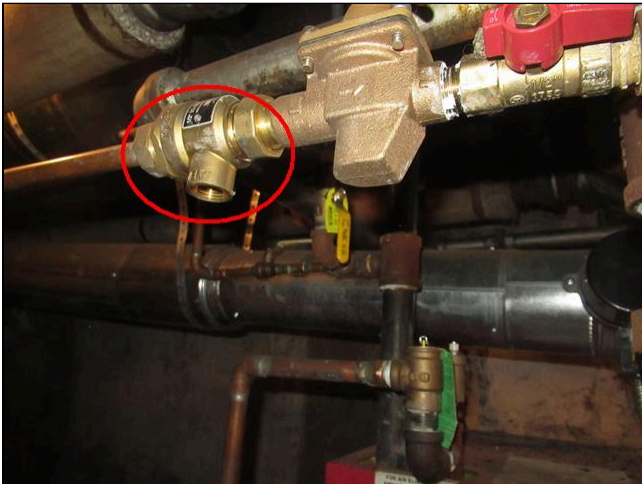
+ 4.2 The extension on the boiler back flow preventer was missing. All boilers are required to have a back flow preventer with an extension to release hot water and steam if there is a drop in the municipal water supply. These prevent cross connection of waste water and supply water. The extension should end between 6 and 12 inches from the floor so that a person will not get scalded should the back flow preventer release. A boiler without a back flow preventer or an improper extension is a safety hazard. I recommend that a licensed plumber remedy this situation.

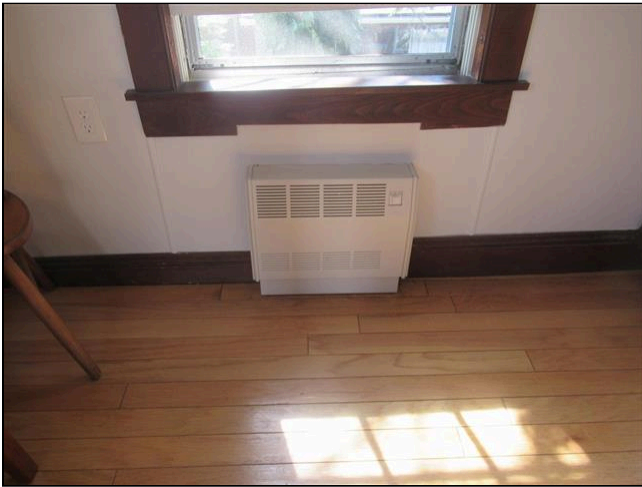
4.4 The kitchen was supplied with a smaller heat source than other rooms of the same size. If you find the kitchen cold during the winter months, you may want to replace this heating unit with one that has a larger BTU output. This is for your information.

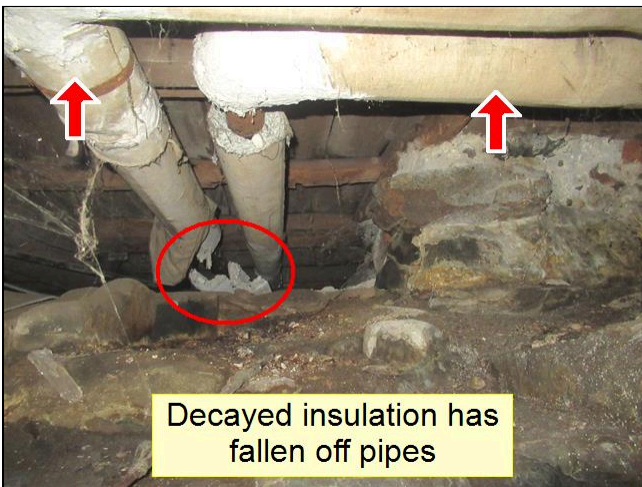
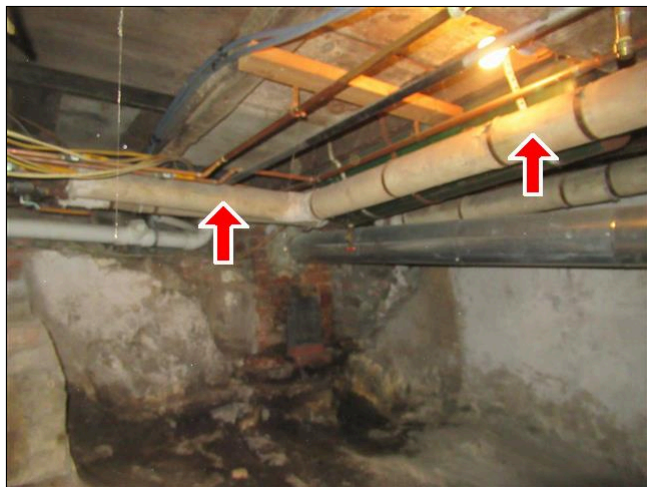
4.5 The insulation on the heating pipes may contain asbestos. This is a safety hazard. If this insulation becomes friable, the asbestos can become airborne making it dangerous. I recommend that this insulation be tested for asbestos. If the insulation tests positive, I recommend removal by a licensed asbestos abatement contractor.

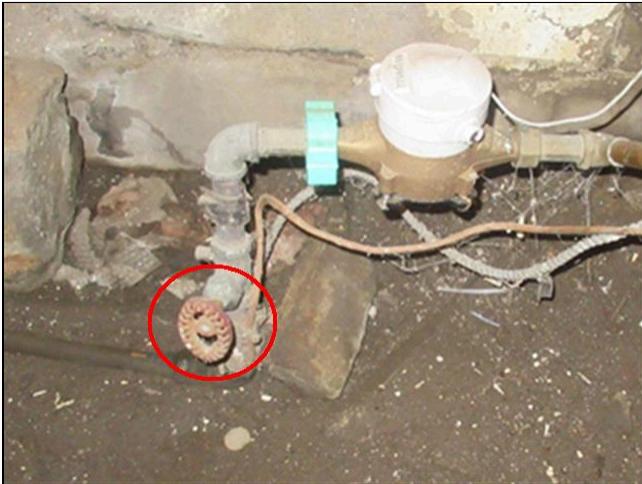
5.0 The main shut off for the water supply was an old gate valve that could fail when used. I recommend that a licensed plumber install a ball valve for ease of use in an emergency.

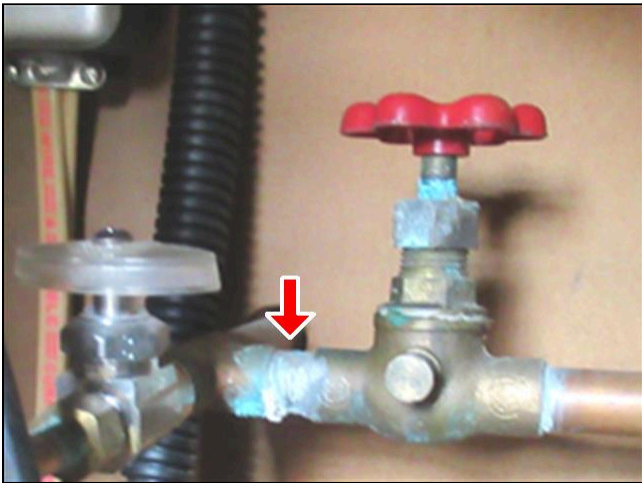
5.1 (1) There was a corroded water supply pipe under the kitchen sink. I recommend that a licensed plumber further investigate and repair as needed.

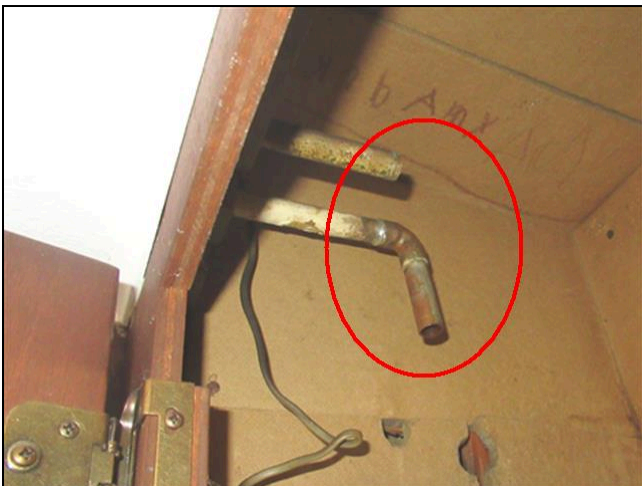
5.1 (2) There were cut pipes in the upper kitchen cabinet adjacent to the bathroom wall. These pipes were uncapped. All cut pipes should be permanently capped. I recommend that a licensed plumber investigate further and properly cap this pipe if found to still be connected to a water source.

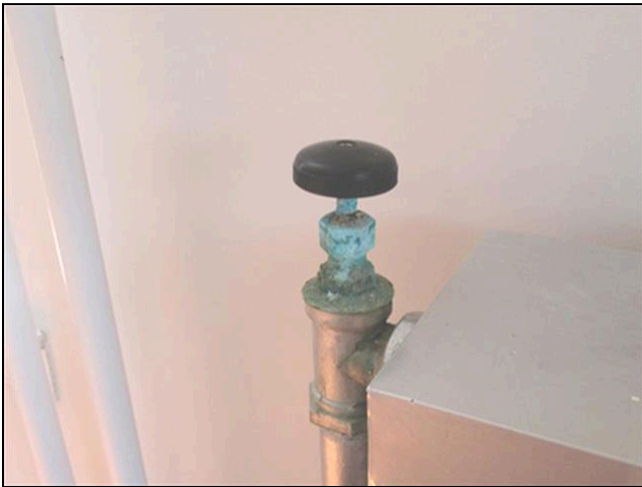
5.1 (3) There was a corroded water supply valves at the living room radiator. There is the potential for a leak at this valve. I

recommend that a licensed plumber repair or replace this valve.

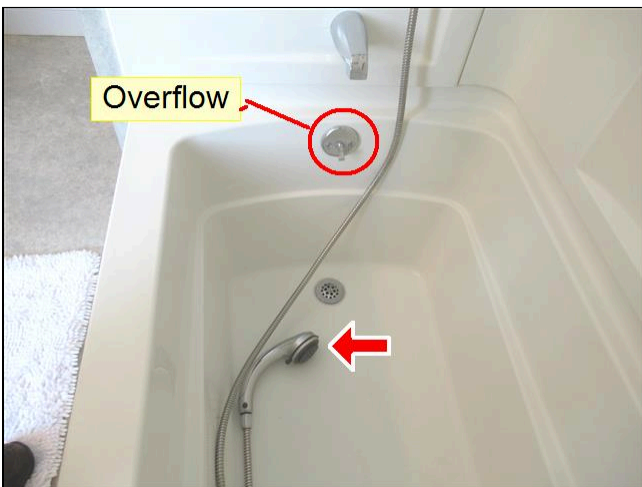
+ 5.2 (2) There was a cross-connection at the second floor bathtub. The hand-held shower head could hang into the bathtub. Cross-connections in a plumbing system are a safety issue. A cross-connection is a condition that allows waste water to be siphoned back into the potable water system. I recommend that a licensed plumber remedy this problem.

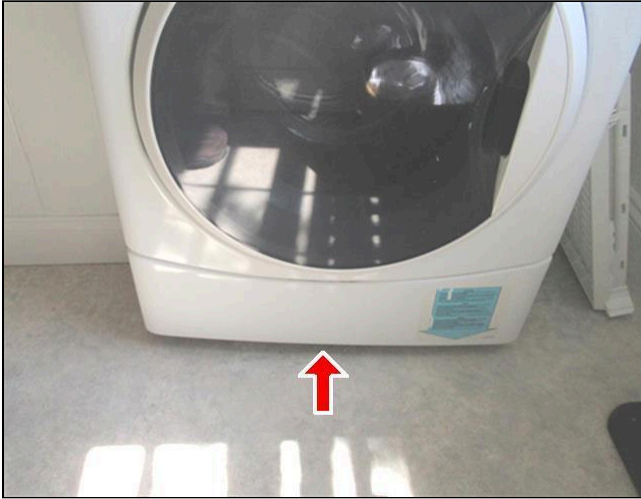
5.2 (3) The washing machine was located in finished space. There was no catch pan under the washing machine. When a washing machine is located in a finished space there should be a catch pan. This pan should have a drain plumbed into it or a sensor mechanism that activates a water supply shut off valve to prevent flooding should the washing machine overflow. I recommend that a catch pan and drain or a catch pan and sensor activated water supply shut off be installed for this washing machine.

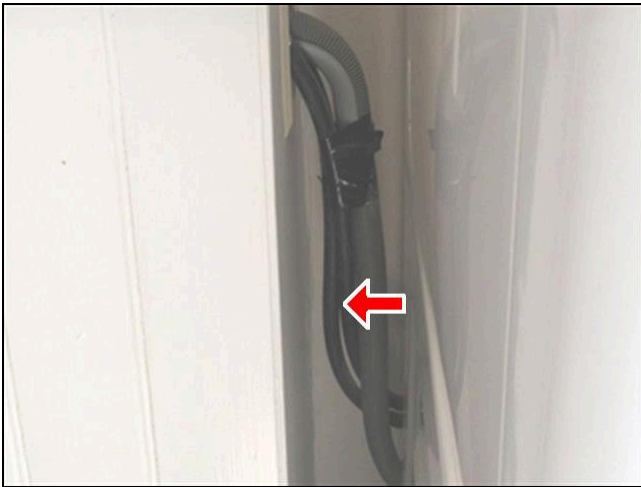
5.2 (4) Rubber lines supplied water to the washing machine. These lines are not rated to remain under constant pressure. Many people do not turn off the valve between loads of laundry. To prevent a burst hose and flooding, I recommend that these lines be upgraded to braided stainless steel lines.

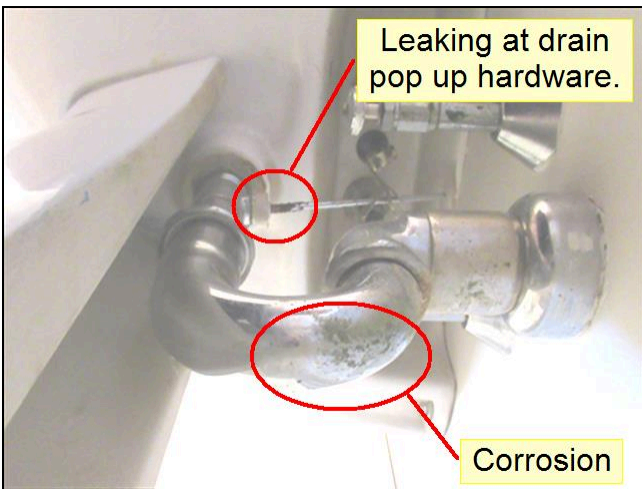
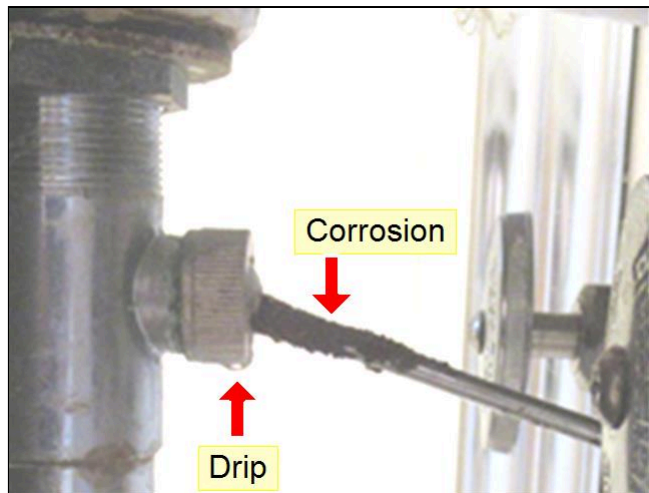
5.4 (2) There was a leak at the first floor bathroom sink drain pop up. There was also corrosion on the bottom of the sink trap. I recommend that licensed plumber repair or replace these components.

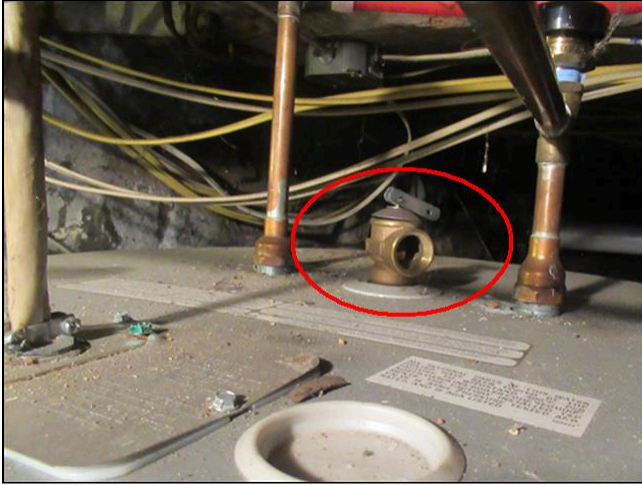
+ 5.7 The pressure relief valve extension on the water heater was missing. All water heaters are required to have a

pressure relief valve with an extension to release hot water and steam if the hot water heater is not functioning properly. The extension should end between 6 and 12 inches from the floor so that a person will not get scalded should the water heater malfunction. A water heater without a pressure relief valve or an improper extension is a safety hazard. I recommend that a licensed plumber remedy this situation.

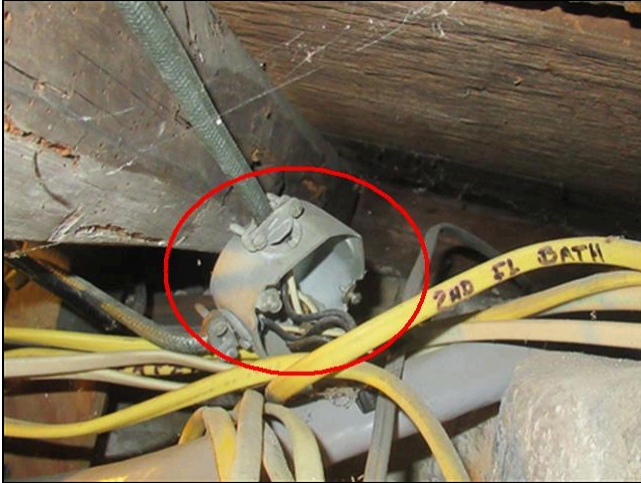
⊕ 6.3 (1) There was a missing cover plate at the junction box above the water heater. There were live wires exposed at this location. I recommend that a cover plate be installed.

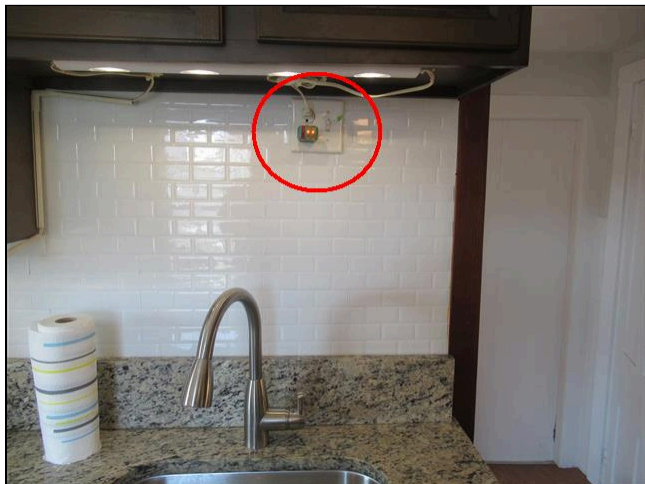
+ 6.4 The electric receptacle above the kitchen sink was not GFCI. All receptacles within 6 feet of water, in the garage, in unfinished areas of the basement, and on the exterior of the house should be equipped with ground fault circuit interrupters (GFCI). GFCI's detect the amperage flow going in and out of the receptacle. If this flow varies by as little as .005 amps, the receptacle will trip. These receptacles should be tested on a monthly basis. I recommend that a licensed electrician install a GFCI plug in this location.

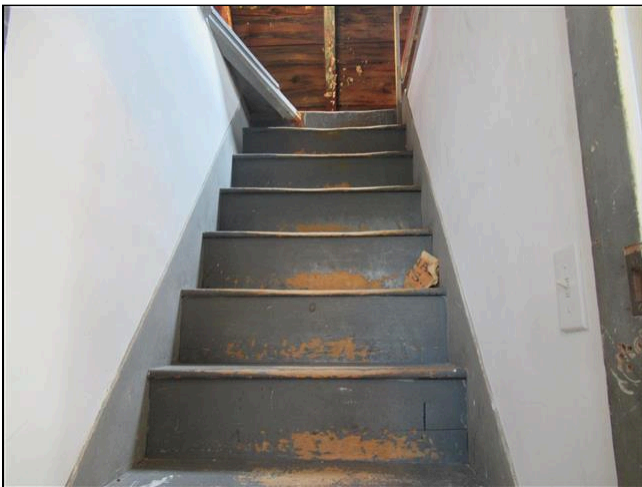
+ 7.2 (2) There was no hand railing at the attic stairs. All stairs with three risers or more should have a handrail. I recommend that a handrail be installed.

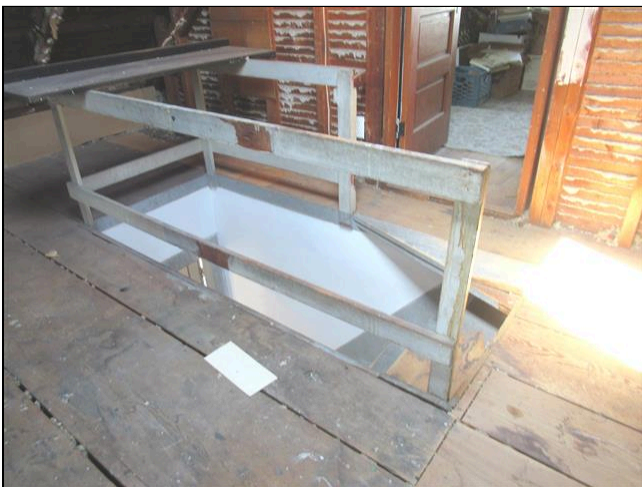
+ 7.2 (3) The attic railing was loose and had no balusters. When balusters are installed, the space between each baluster should not exceed 4 inches. The railing should be able to withstand 200 pounds of force. I recommend installation of a railing with balusters.

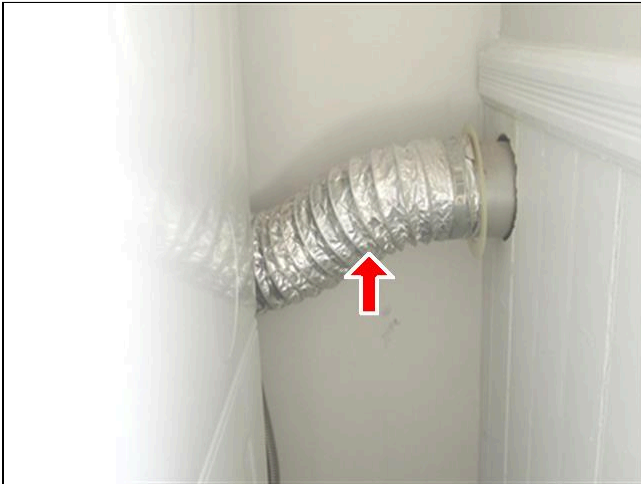
7.5 The dryer vent was flexible metal. This material is prone to clogging. I recommend that the dryer vent be replaced with stiff metal pipe to reduce lint build up and to increase the efficiency of the dryer.
