# Inspection Report

**Property Address:**  
1313 Mockingbird Lane  
Medford MA 02155

**Omega Home Inspections, LLC**

<b>Date:</b> 7/9/2020	<b>Time:</b> 12:00 PM - 03:00 PM	<b>Report ID:</b> Sample Townhouse Report
<b>Property:</b> 1313 Mockingbird Lane Medford MA 02155	<b>Customer:</b> Joe Smith Mr. Joe Smith	<b>Real Estate Professional:</b> Janet Jones ACME Realtors

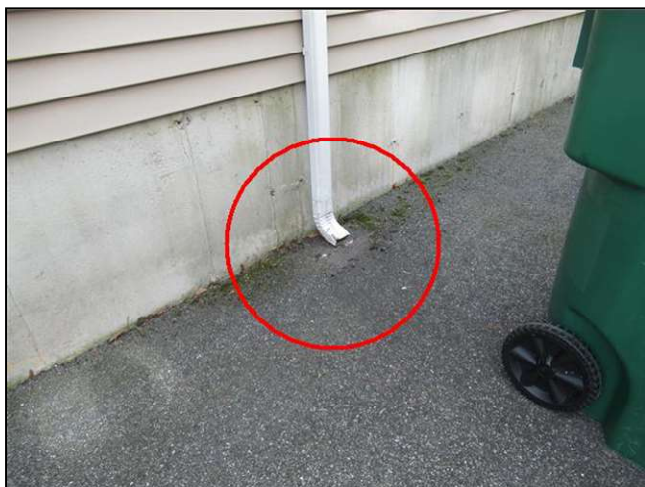
**1.3** A roof water downspout discharged on to the driveway. There is the potential for slippery conditions in winter. If found to be a problem, I recommend that a landscape contractor install an underground drain and drywell for this downspout.

A roof water downspout discharged on to the driveway. There is the potential for slippery conditions in winter. If found to be a problem, I recommend that a landscape contractor install an underground drain and drywell for this downspout.

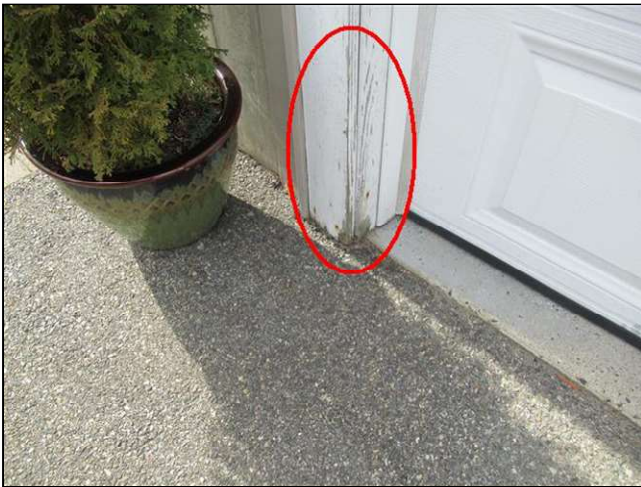
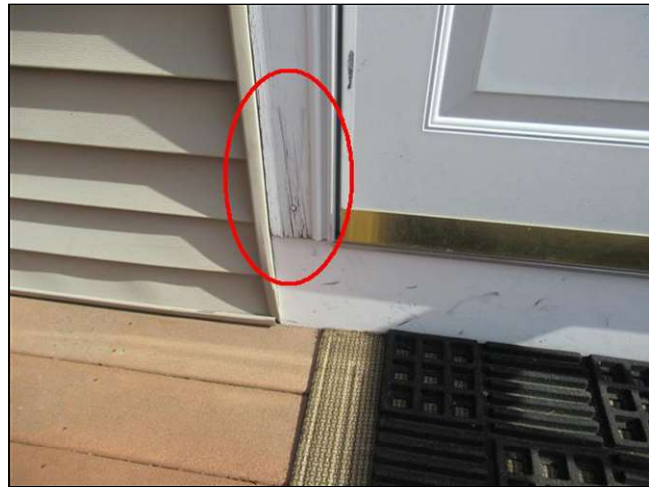
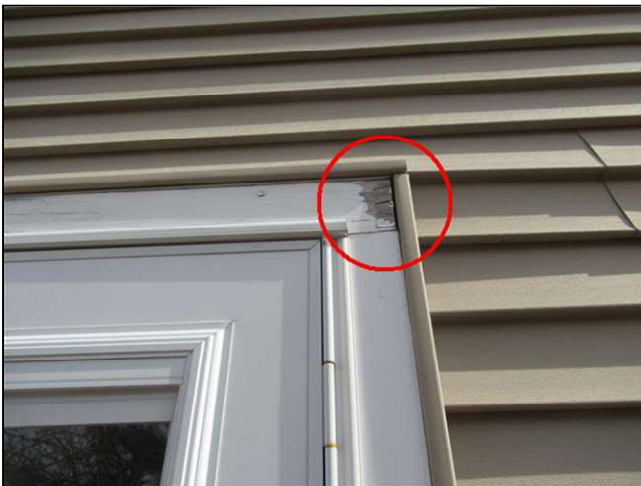
2.0 (1) The paint was chipping and peeling at the garage and back door trim. The longevity of a paint job depends primarily on the prep-work. The decayed areas should be scraped, caulked and a full coat of primer applied before the finish coat. I recommend that the decayed areas be properly prepped and re-painted.

(1) The paint was chipping and peeling at the garage and back door trim. The longevity of a paint job depends primarily on the prep-work. The decayed areas should be scraped, caulked and a full coat of primer applied before the finish coat. I recommend that the decayed areas be properly prepped and re-painted.

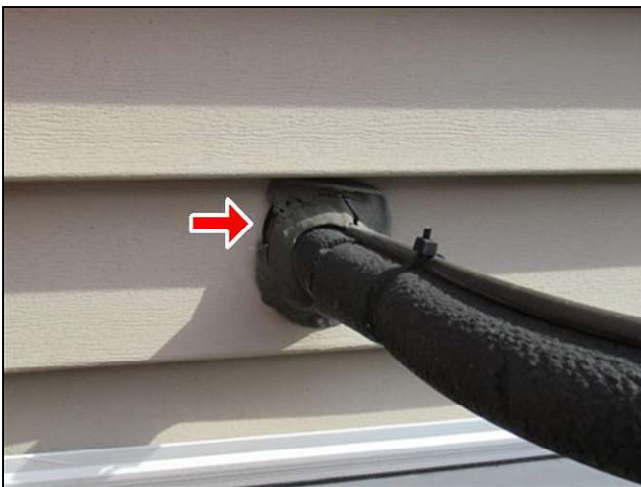
2.0 (2) There was a gap where the AC refrigerant line penetrated through the wall of the house. This gap will reduce the energy efficiency of the house and could potentially allow insects access in to the house. I recommend that this gap be properly sealed.

(2) There was a gap where the AC refrigerant line penetrated through the wall of the house. This gap will reduce the energy efficiency of the house and could potentially allow insects access in to the house. I recommend that this gap be properly sealed.

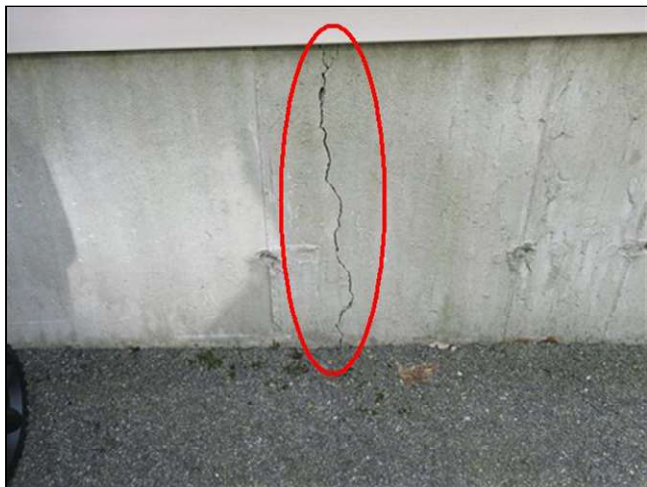
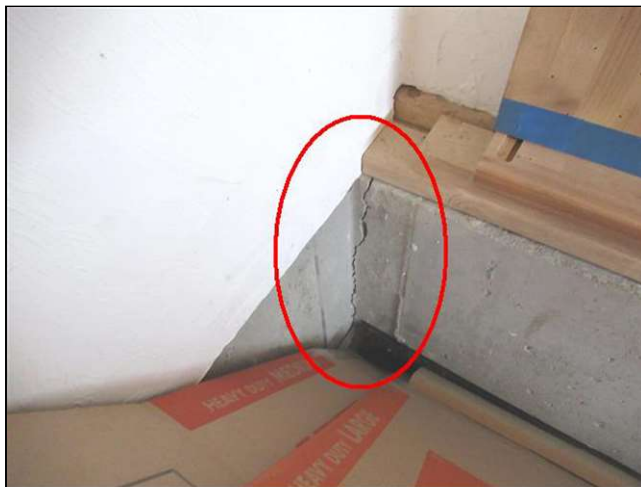
2.2 (1) There was a crack at the interior and exterior right side of the house where the garage foundation abutted the house foundation. The crack appeared to be from settlement. I recommend that this crack be repaired by a qualified mason and then monitored for further movement.

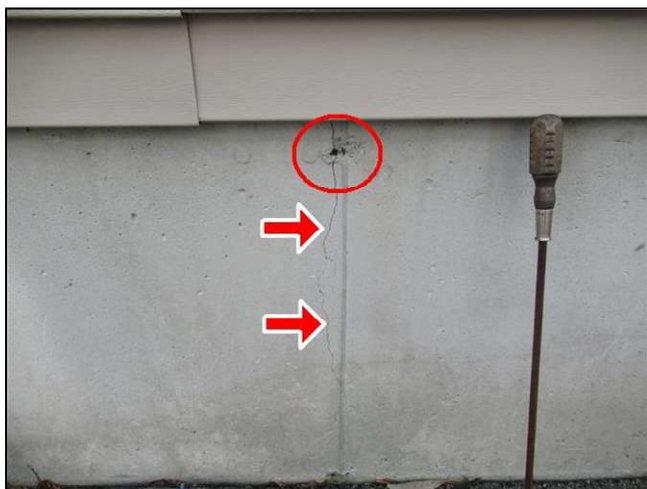
2.2 (2) There were unsealed holes from where form ties had been removed from the foundation. Steel form ties are used during construction to keep the forms in place while the concrete foundation is poured. These form ties are then broken off from the interior and exterior and the small voids are filled with concrete. If the form ties are left exposed the metal can expand due to rust. This will crack adjacent areas of the foundation. I recommend that the form ties be sealed with concrete to prevent rusting.

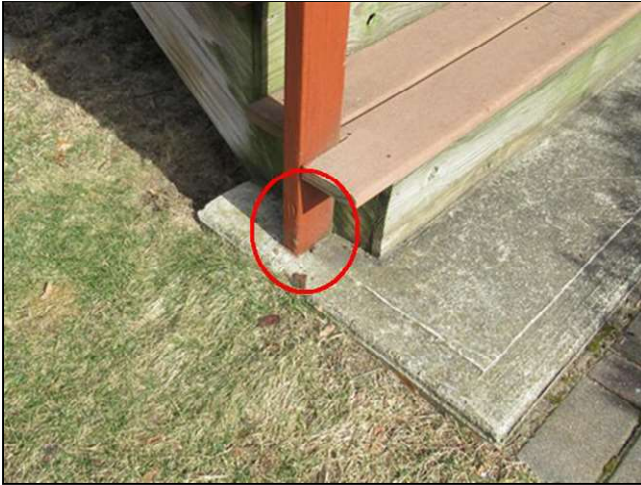
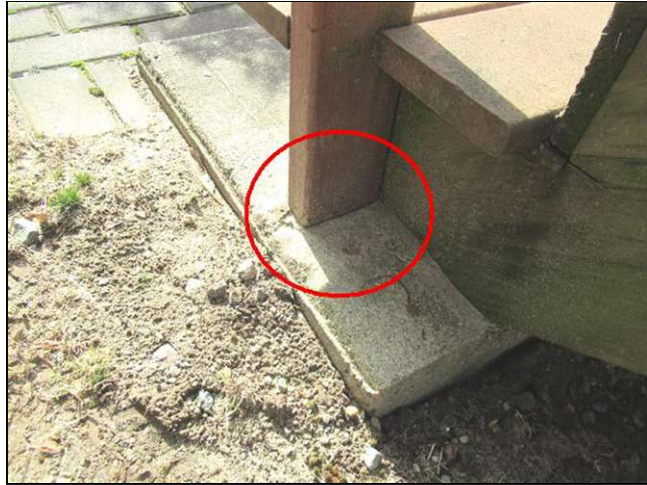
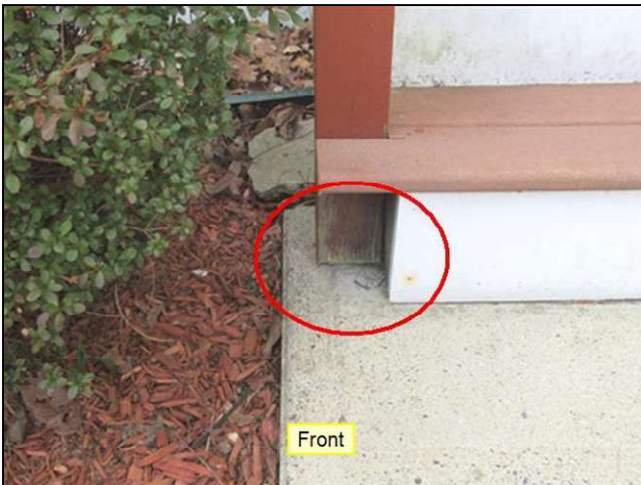
2.6 (3) The posts supporting the hand rails at the front and rear steps were set directly on top of the concrete pad, instead of on stand-off post anchors. Water will wick up into these posts from the concrete. There is the potential for decay in the posts. I recommend monitoring the posts for decay, and repair or replacement of the posts if needed by a licensed contractor.

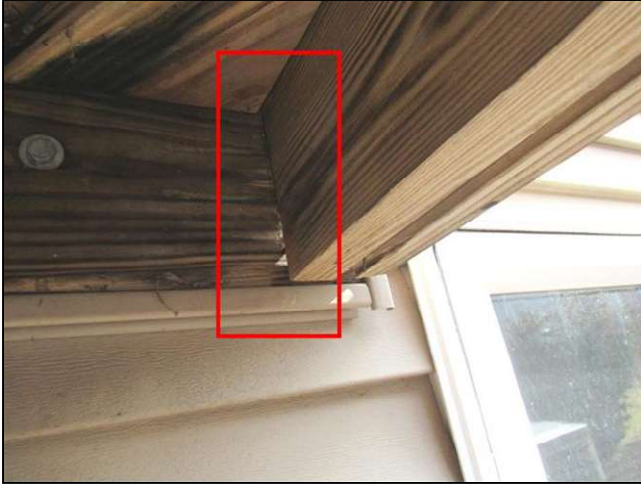
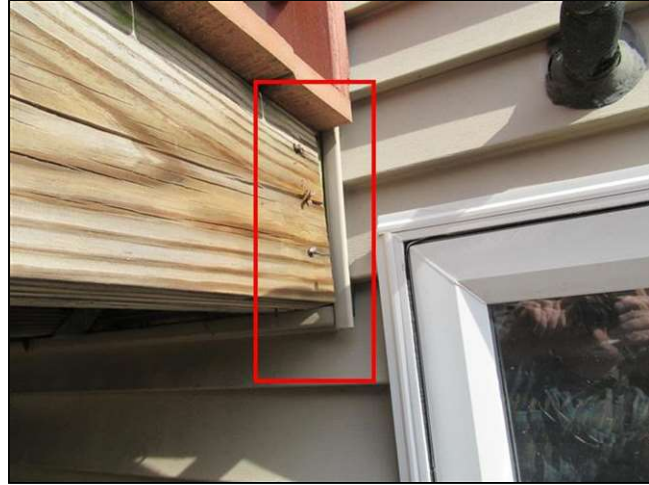
2.6 (4) The perimeter joist on the right side of the rear deck was split and pulling away from the ledger board due to inadequate fasteners. One nail, at the split, could be pulled out by hand. This can threaten the structural integrity of the deck. I recommend that a qualified contractor replace the spilt rim joist and use the appropriate mechanical fasteners to secure it to the ledger board.

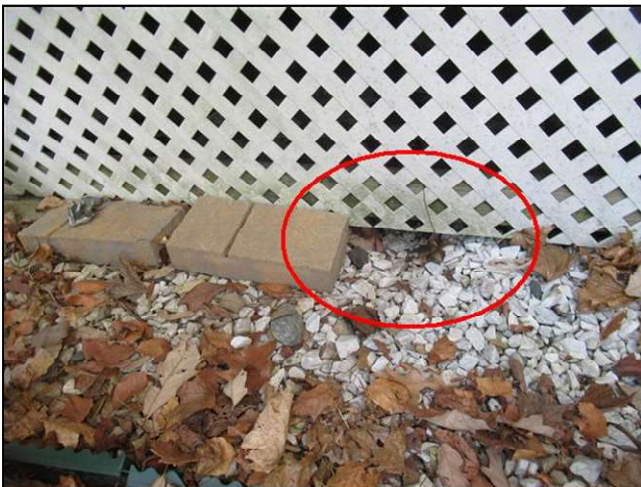
2.6 (5) There was a hole under the lattice at the front porch. There is a potential for critters to get under the porch. I recommend that the holes be filled back in.

(5) There was a hole under the lattice at the front porch. There is a potential for critters to get under the porch. I recommend that the holes be filled back in.

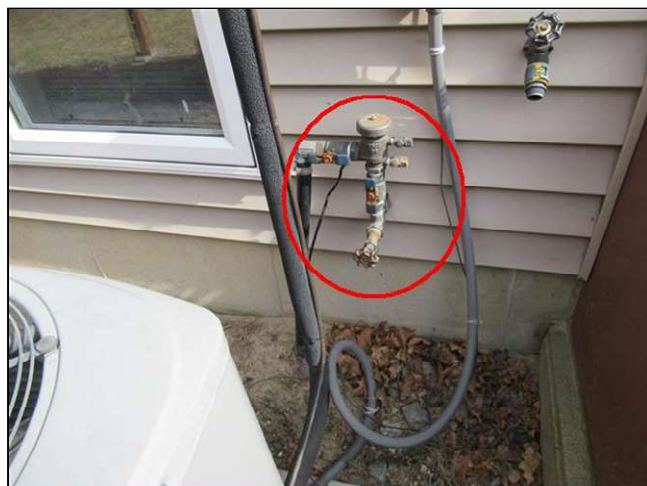
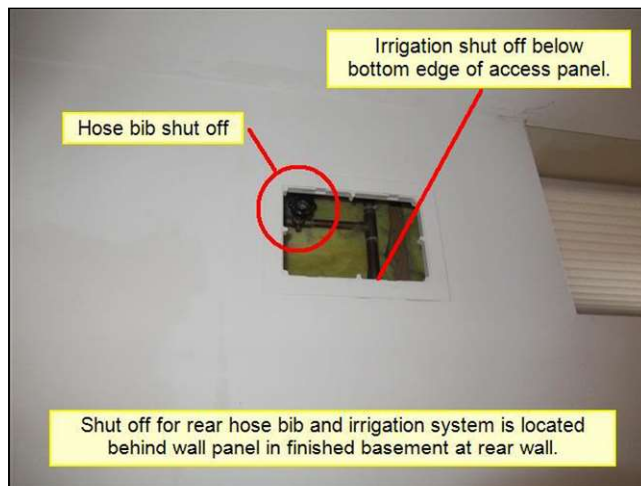
2.10 There was irrigation system plumbing at the rear of the building. It is important that a irrigation system company blow water out of the lines before the ground freezes. This irrigation system was out of scope for this home inspection and was not inspected.

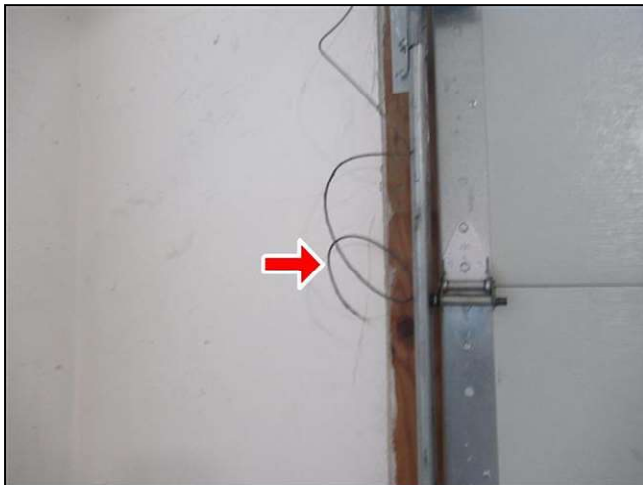
**+** 3.4 (2) The safety cable on the right side of the garage door was damaged. In the event of a spring breaking the safety cables would prevent the spring from injuring people or property. I recommend the safety cable be repaired.

(2) The safety cable on the right side of the garage door was damaged. In the event of a spring breaking the safety cables would prevent the spring from injuring people or property. I recommend the safety cable be repaired.

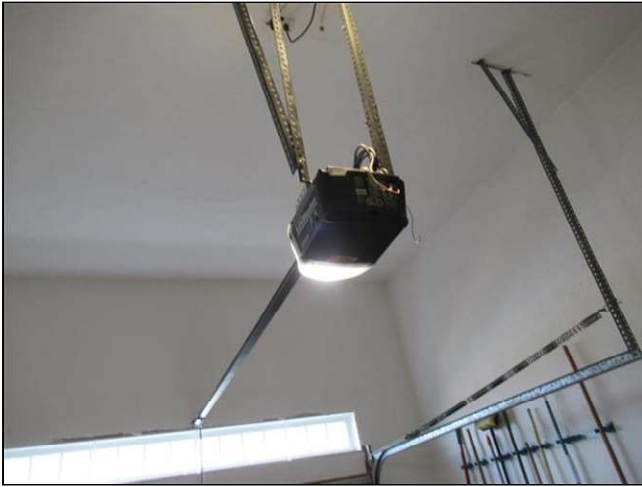
3.7 The garage door did not reverse when met with resistance. All garage doors should have two means of safety reverse; one a pressure switch in the opener and the 2nd a beam along the bottom of the door opening. I recommend repair or replacement of the garage door opener so that the door reverses properly.

The garage door did not reverse when met with resistance. All garage doors should have two means of safety reverse; one a pressure switch in the opener and the 2nd a beam along the bottom of the door opening. I recommend repair or replacement of the garage door opener so that the door reverses properly.

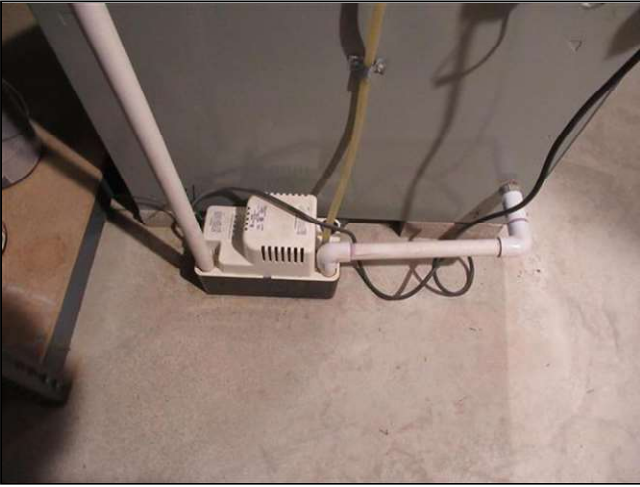
5.0 (2) There was no neutralizer on the furnace condensate drain. The condensate from a heating system is very acidic and can deteriorate the waste pipes. I recommend that a neutralizer be installed on the condensate drain for the furnace.

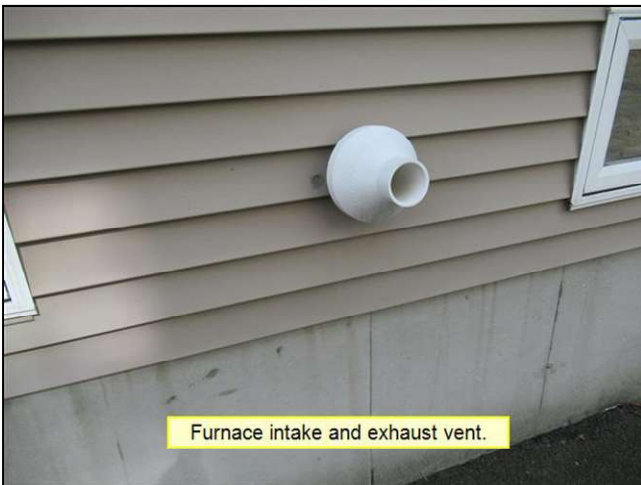
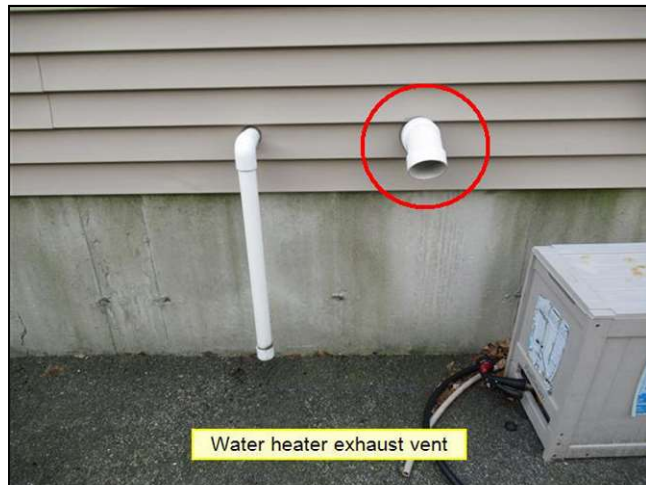
**+** 5.3 There were gas intake and exhaust vents at the right side of the structure. If these vents become covered with snow or other debris the system can vent into the basement creating dangerous carbon monoxide conditions. This is a **safety issue**. I recommend that these vents be kept clear of snow and other debris at all times. This is for your information.

There were gas intake and exhaust vents at the right side of the structure. If these vents become covered with snow or other debris the system can vent into the basement creating dangerous carbon monoxide conditions. This is a **safety issue**. I recommend that these vents be kept clear of snow and other debris at all times. This is for your information.

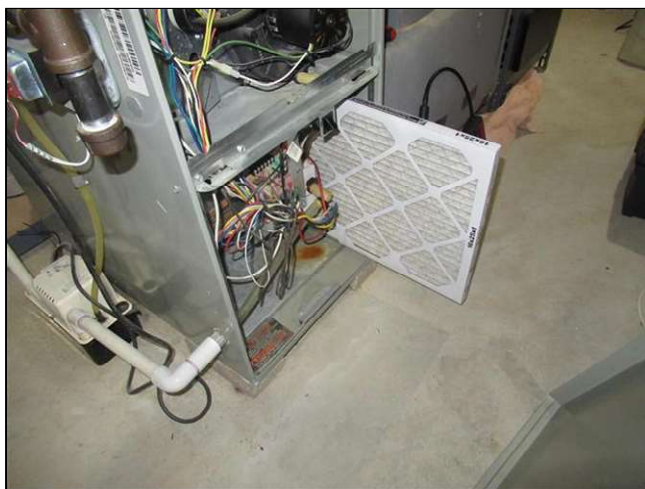
5.5 The air filter size for the forced air unit supplying the first floor is 16 x 25 x 1. This is for your information.

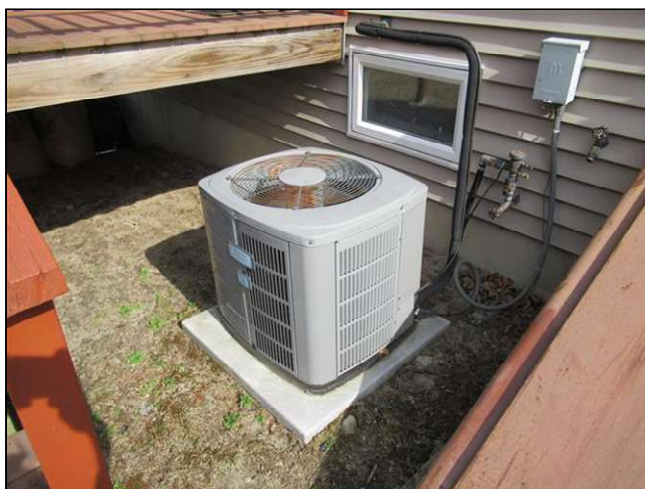
5.7 (2) The exterior AC compressor/condenser unit was manufactured in 2004. These units typically last 15-20 years if well maintained, less if not. The Seasonal Energy Efficiency Rating, or SEER, has changed, requiring AC systems to be more efficient. When the exterior compressor condenser unit is replaced the copper line set and the interior AC coil will also have to be updated to keep in line with the new efficiency standards. This increases the scope and cost of the work. I recommend planning for replacement of the air conditioning system.

(2) The exterior AC compressor/condenser unit was manufactured in 2004. These units typically last 15-20 years if well maintained, less if not. The Seasonal Energy Efficiency Rating, or SEER, has changed, requiring AC systems to be more efficient. When the exterior compressor condenser unit is replaced the copper line set and the interior AC coil will also have to be updated to keep in line with the new efficiency standards. This increases the scope and cost of the work. I recommend planning for replacement of the air conditioning system.

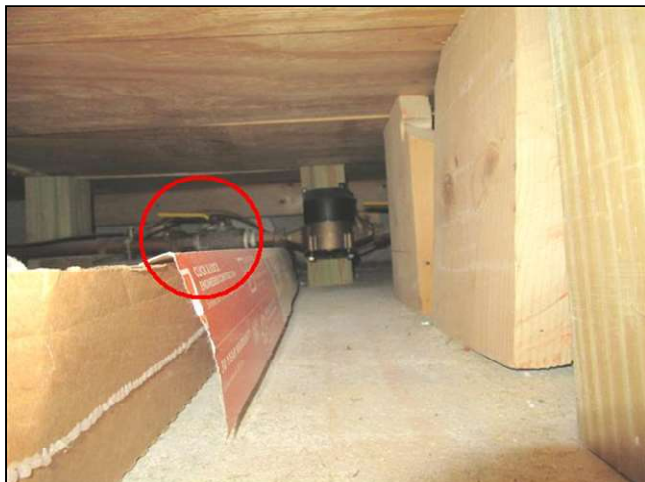
6.0 The main water shut off was located at the water meter at the left side of the basement under the stairs and under a storage platform. This is for your information.

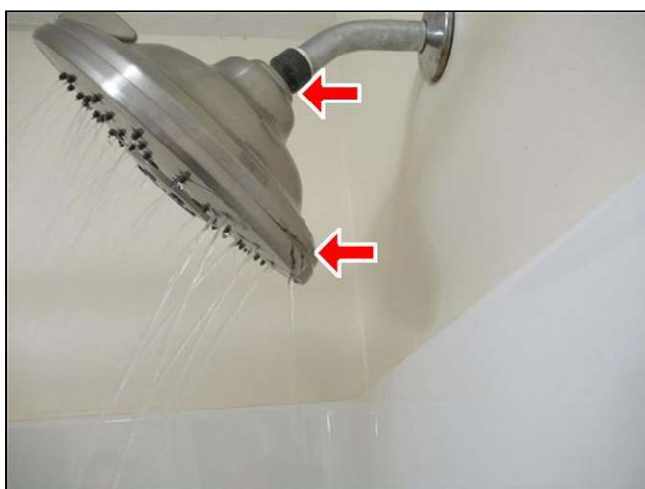
6.2 (2) The second floor bathroom shower head leaked. I recommend that the shower head be repaired or replaced.

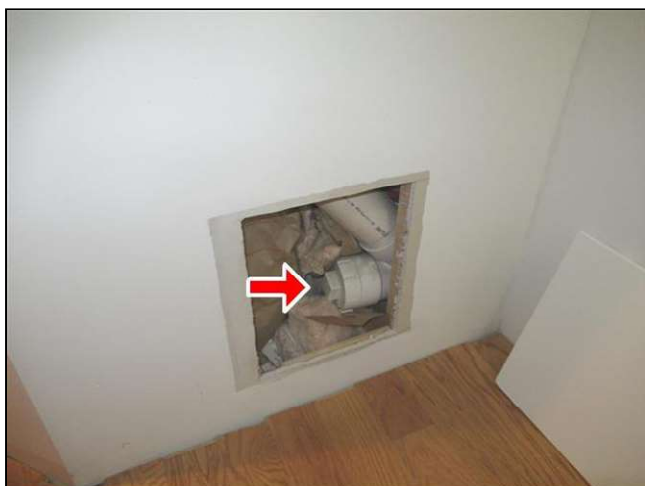
6.4 (1) The main plumbing clean out was located at the front of the basement behind an access panel. This is for your information.

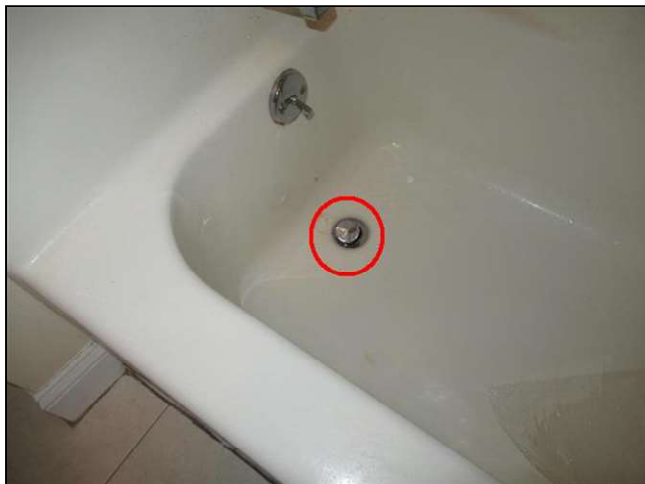
6.4 (2) The pop-up did not operate in the third floor bathroom tub. There is no way to hold water in the fixture with this pop-up. I recommend that a licensed plumber repair or replace the pop-up.

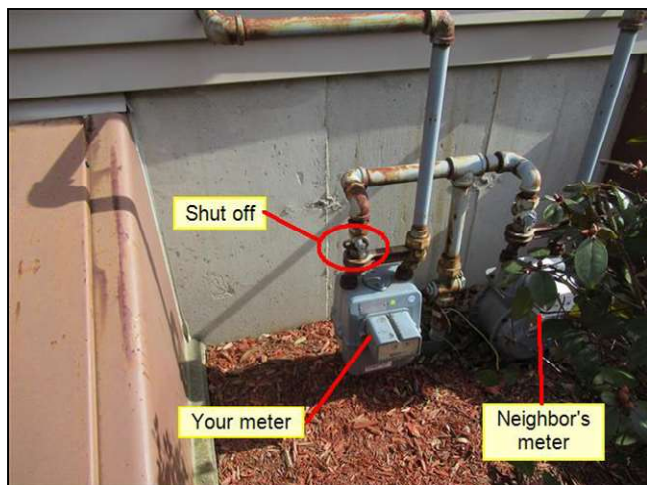
6.9 The main gas shut off was located at the gas meter at the back of the house. This is for your information.

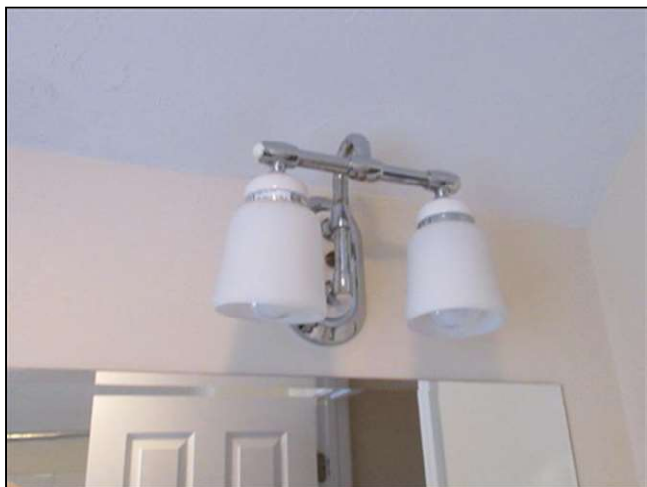
**+** 7.3 There was a loose electric light fixture at the third floor bathroom over the sink. It was not operating at the time of the inspection. All fixtures should be properly affixed to the wall. I recommend that a licensed electrician properly secure this fixture and verify it is properly wired.

There was a loose electric light fixture at the third floor bathroom over the sink. It was not operating at the time of the inspection. All fixtures should be properly affixed to the wall. I recommend that a licensed electrician properly secure this fixture and verify it is properly wired.

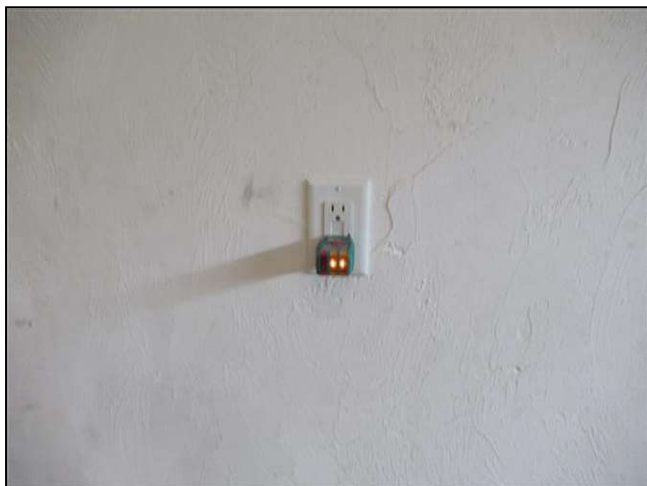
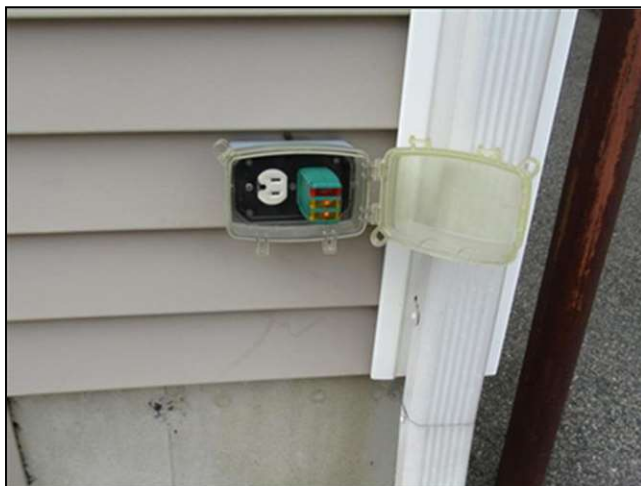
**+** 7.4 (2) The GFCI in the garage did not trip when tested. The receptacle just outside the garage door on the right did not trip either. The two may be on the same circuit. All receptacles within 6 feet of water, in the garage, in unfinished areas of the basement, and on the exterior of the house should be equipped with ground fault circuit interrupters (GFCI). GFCI's detect the amperage flow going in and out of the receptacle. If this flow varies by as little as .005 amps, the receptacle will trip. These receptacles should be tested on a monthly basis, if they are not tested they frequently get stuck in the "on" position and will not trip when needed. I recommend that a licensed electrician replace the GFCI's where needed.

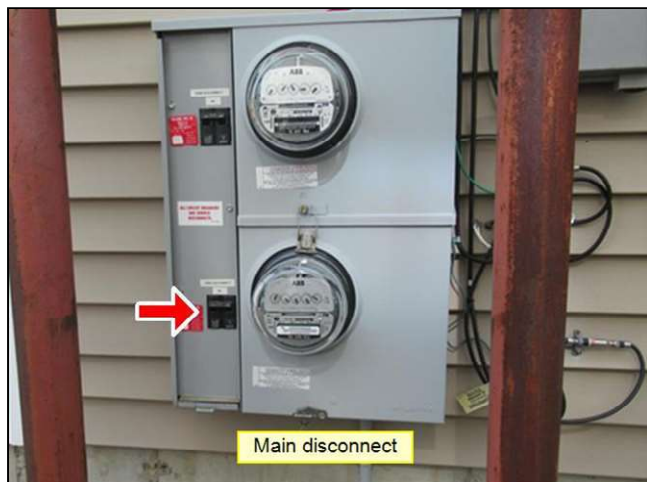
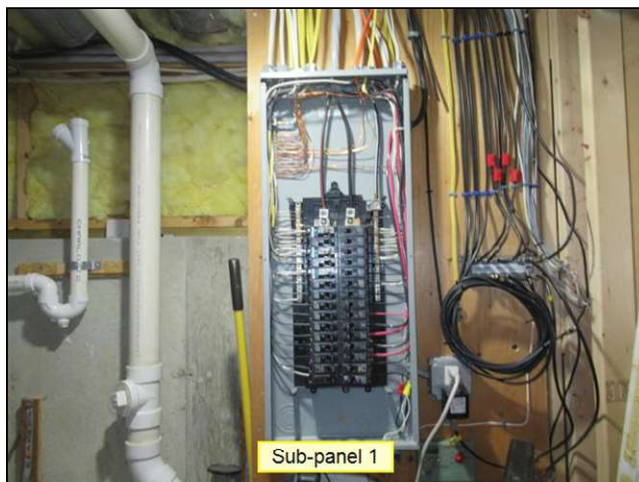
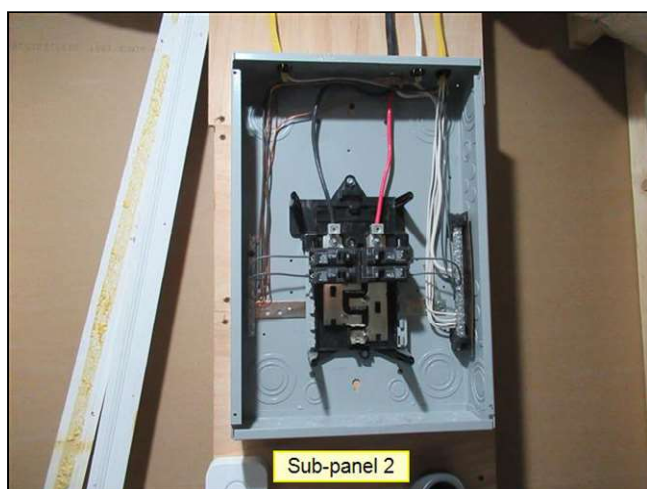
7.6 The main disconnect was located at the exterior right front corner of the building and the sub panels were located in the basement mechanical room. This is for your information.

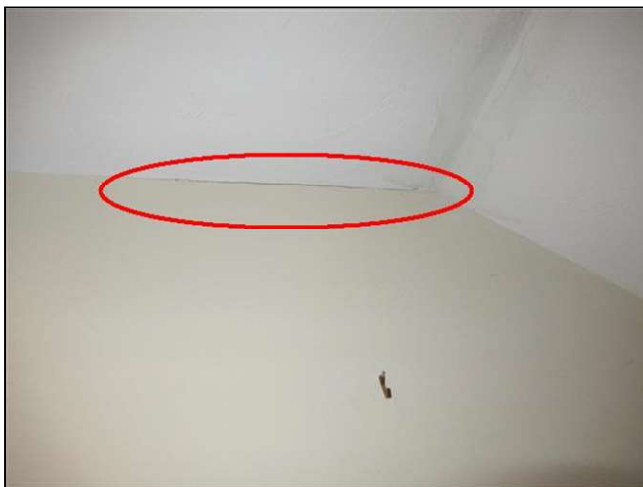
**8.0** There were cracks in the ceiling in the third floor bedroom. I recommend that a qualified painter prep and paint these areas. I recommend monitoring the cracks for further movement.

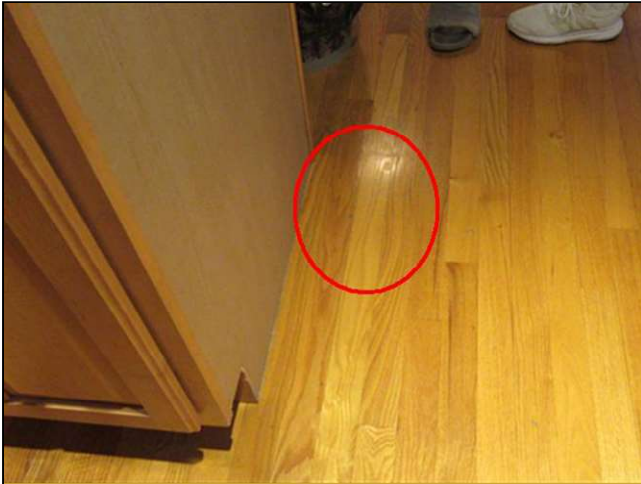
8.1 The floor in the kitchen was dented at the end of the peninsula cabinet. If the aesthetics of this are an issue, then I recommend replacing the damaged flooring with new floor, taking care to match the finish.

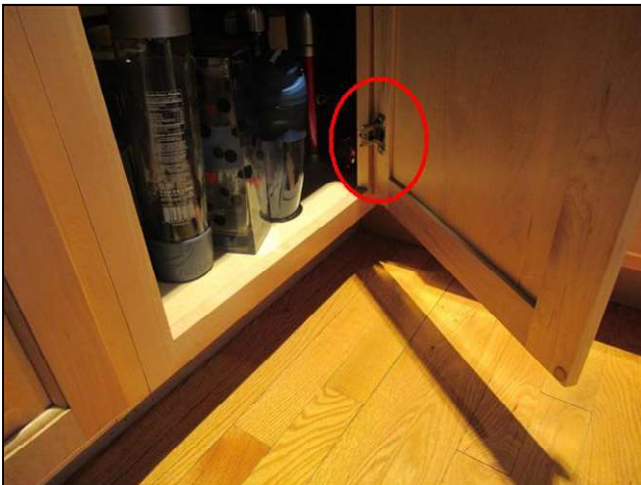
8.3 (1) Kitchen cabinet door was loose to the right of the sink base cabinet. I recommend that a handyman repair/adjust the kitchen door hinge.

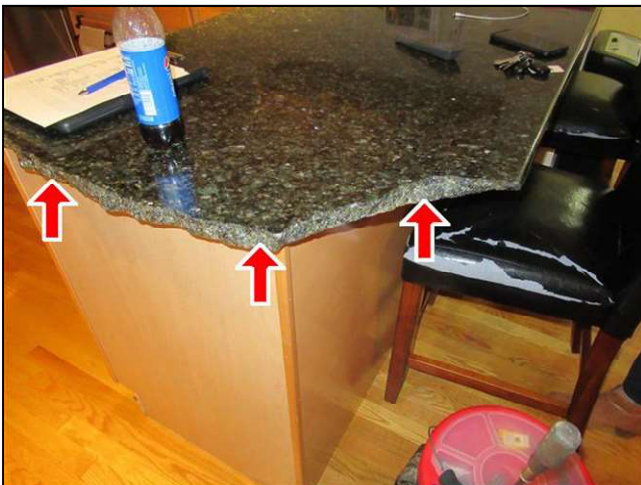
8.3 (2) The countertop was broken off at the end of the peninsula. I recommend that this be replaced by a qualified kitchen countertop company.

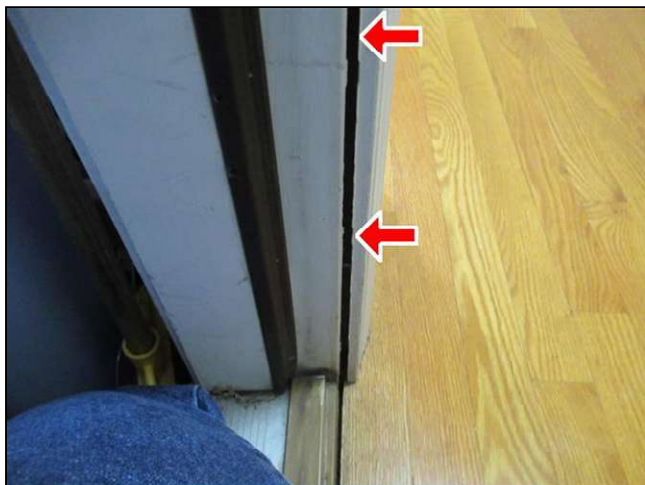
**8.6** The door trim at the door from the house into the garage has pulled away from the door jamb. I recommend that a qualified carpenter repair this gap.

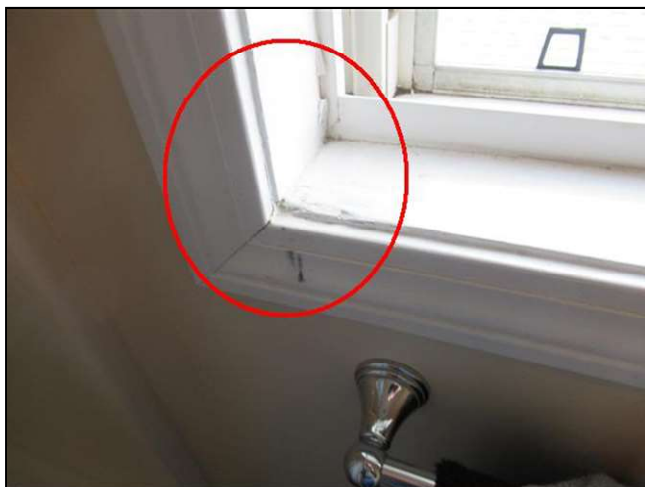
**8.7** The paint finish at the third floor bathroom window trim was deteriorating. I recommend this surfaces be properly sanded, primed and refinished with a finish coat of moisture resistant paint.
