Inspection Report

Historic Sample

Property Address:
10 Sample Rd
Sample MA

Omega Home Inspections, LLC

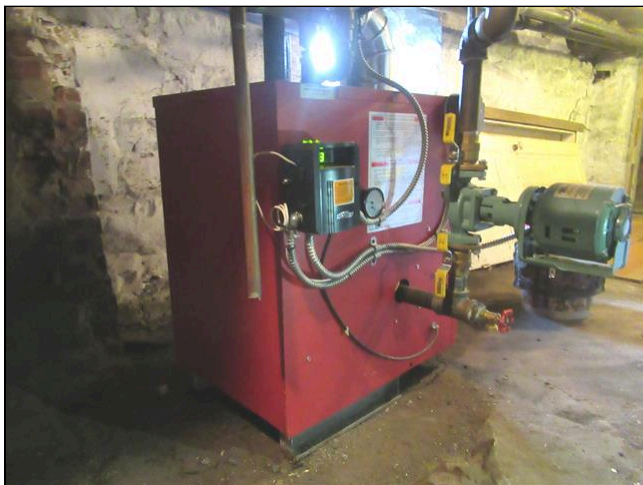
4.0 (1) The boiler was manufactured in 2014. This is for your information.

4.0 (2) The boiler requires regular maintenance for safe operation. I recommend that the system be serviced every year.

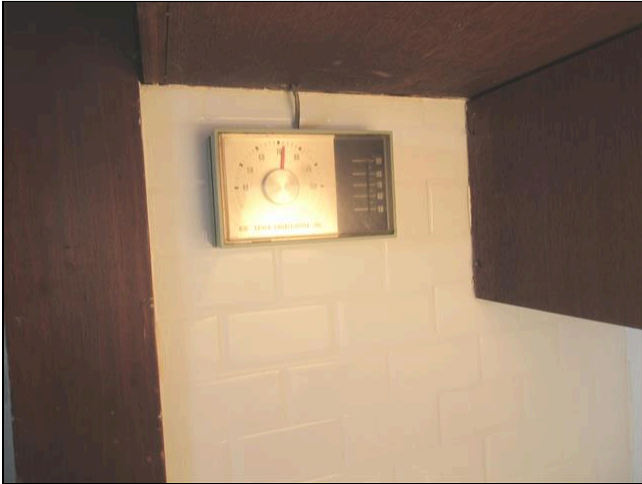
4.1 It was disclosed at the home inspection that this thermostat was no longer connected to the heating system.

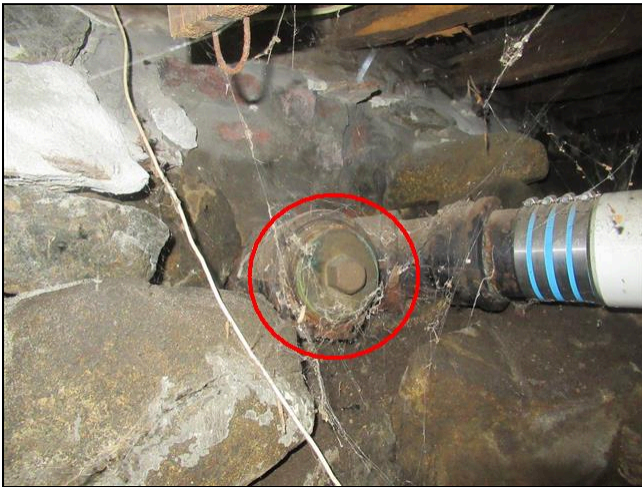
5.4 (1) The main plumbing clean out was located at the right side of the basement. This is for your information.

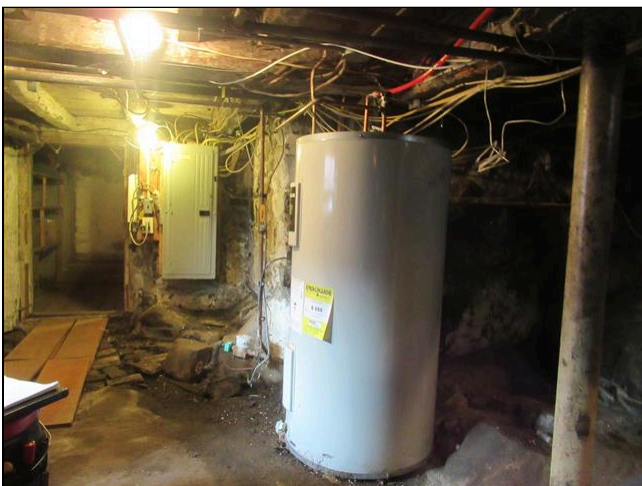
5.5 Based on information obtained online, the electric water heater was manufactured in 2015. This is for your information.

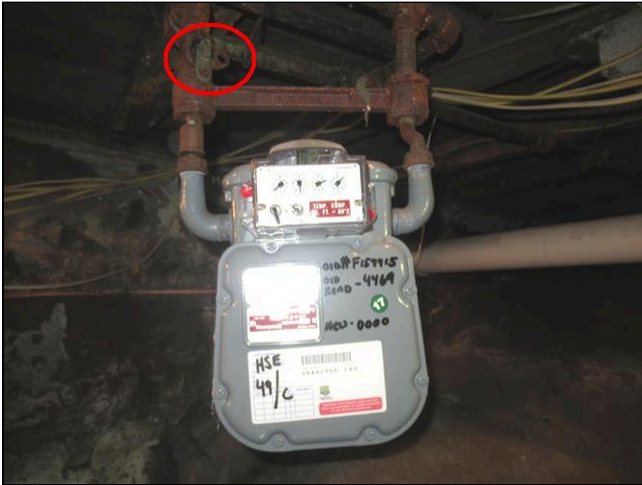
5.9 The main gas shut off was located at the gas meter at the right side of the basement. This is for your information.

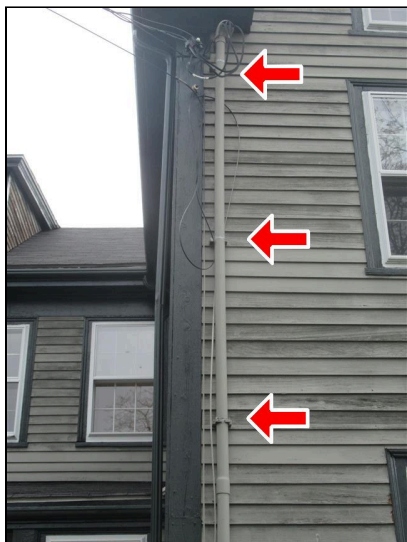
6.0 The wall anchors for the electrical service entrance conduit were broken and or missing. This is often caused by the UV rays of the sun. I recommend that a licensed electrician replace the wall anchors.

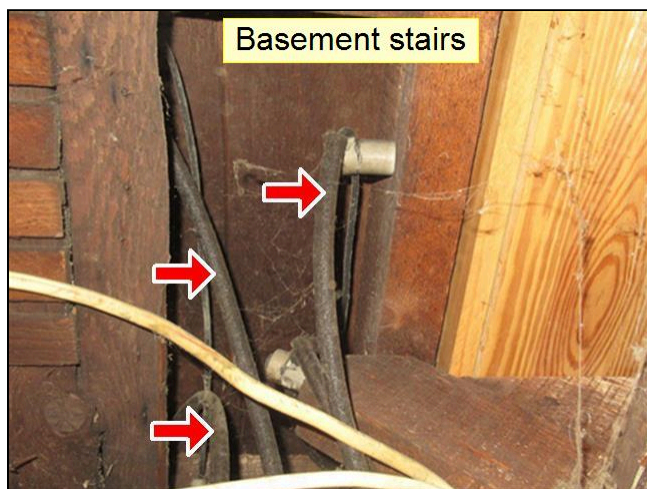
6.2 There was active knob-and-tube wiring in house. The extent of knob and tube wiring could not be determined. Knob-and-tube wiring is found in older houses built before the 1930's. Knob-and-tube wiring is a safety hazard because the junctions are not housed in junction boxes, the system includes a hot and neutral wire but no ground wire, and the wires are at least 80 years old. I recommend further investigation of the extent of this wiring in the building by a licensed electrician. I recommend replacement of the knob-and-tube wiring. It is critical to ensure that knob-and-tube wiring is removed before adding insulation to the house. Insulation in contact with knob-and-tube wiring is a fire hazard. Knob and tube wiring was also identified in the attic which should also be inspected by a licensed electrician.

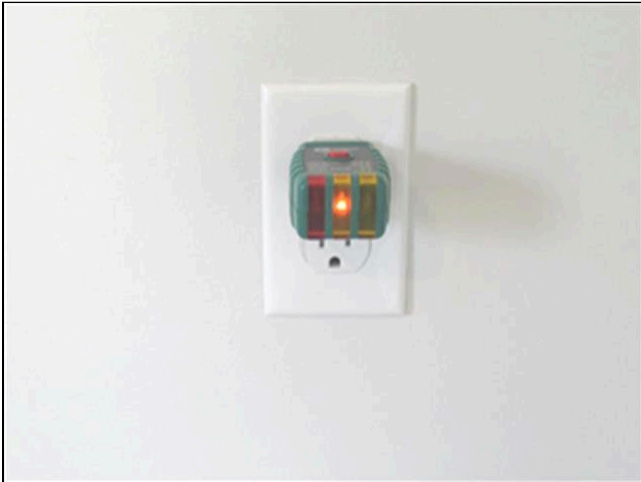
⊕ 6.3 (3) One of the electrical receptacles in the second floor left side room and the second floor front bedroom tested for open grounds. Devices plugged into these receptacles will not be grounded and are a safety hazard. I recommend that a licensed electrician repair these receptacles.

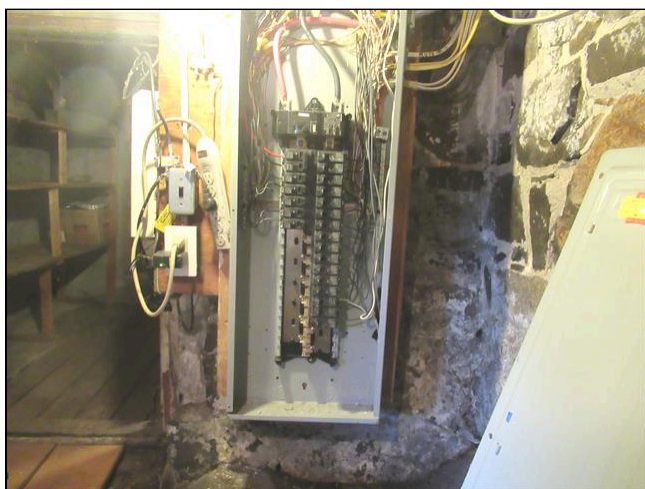
6.6 The main panel was located on the right side of the basement. This is for your information.

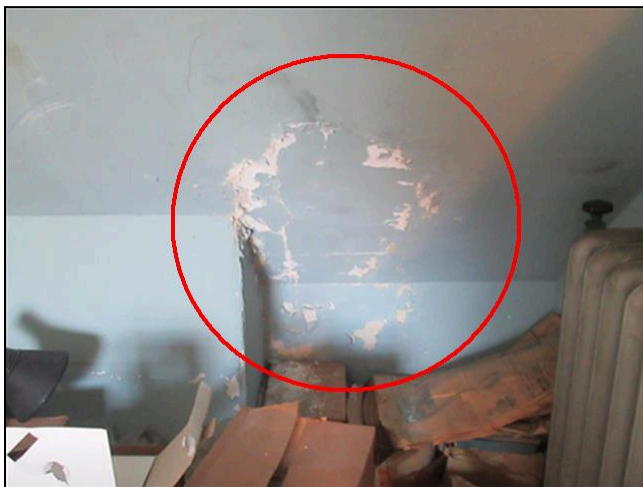
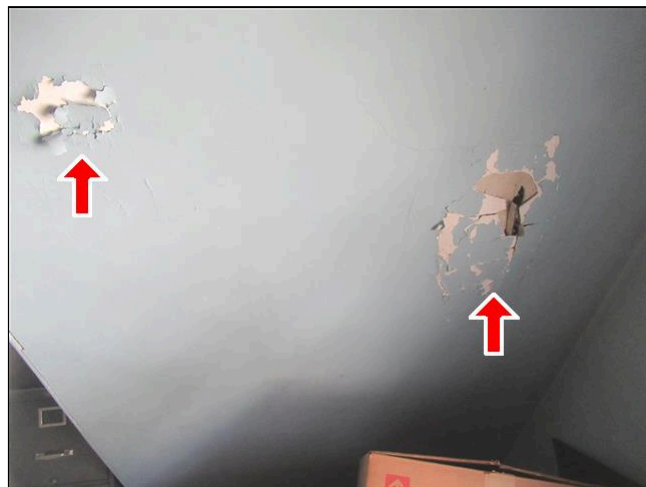
7.0 (2) There were stains and decay in the ceiling in the finished room in the attic. The area was dry at the time of inspection when tested with a framex non invasive moisture meter. If you plan on using this room, I recommend that the ceiling be repaired and painted and then monitored for further decay.

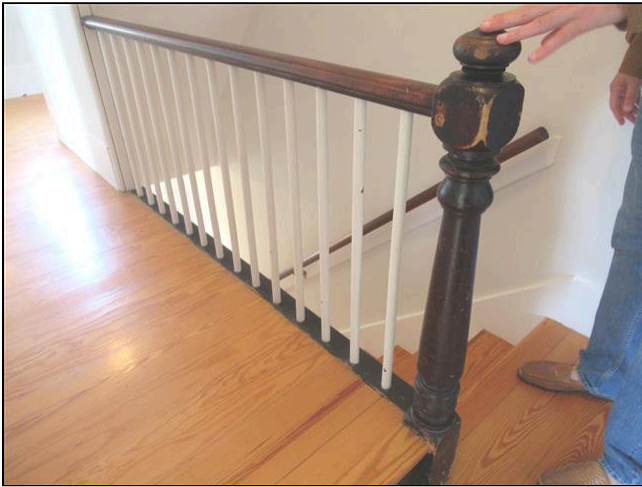
+ 7.2 (1) The stair railing at the second floor was loose. Current building practice states that guardrails should be able to withstand 200 pounds of pressure. I recommend that this railing be repaired.

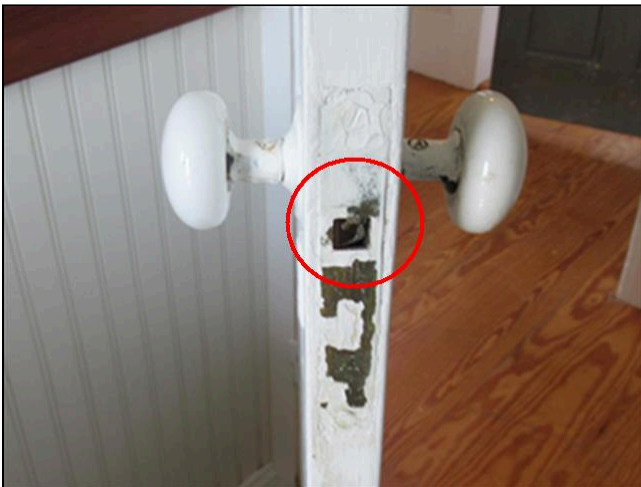
7.6 (2) The second floor bathroom door would not latch closed because the latch was stuck. I recommend that a qualified handyman repair this latch.

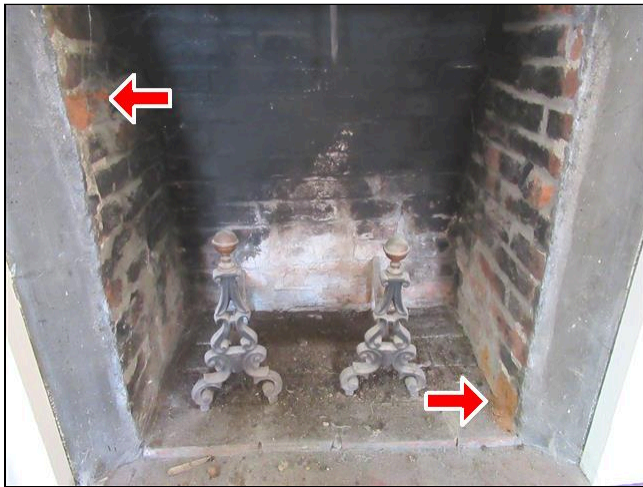
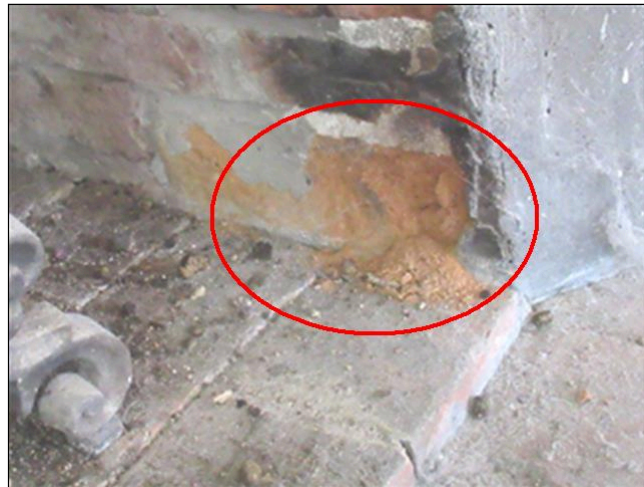
8.0 (1) There was spalling at a few bricks in the fireplace firebox. This happens when the outer layer of the masonry chips off. The inner softer portion of the masonry is then exposed. I recommend that a qualified chimney sweep repair or replace this brick. Recommended accreditations for chimney sweeps; CSIA Chimney Sweep Institute of America and NFI National Fire Place Institute.

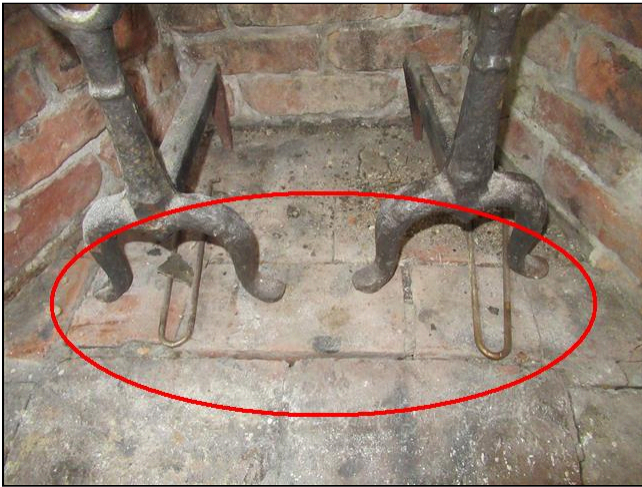
8.0 (2) The masonry at the bottom of the second floor fireplace was deteriorated and in need of pointing. I recommend that a qualified chimney sweep repair this masonry. Recommended accreditations for chimney sweeps are: CSIA Chimney Sweep Institute of America; NFI National Fire Place Institute.

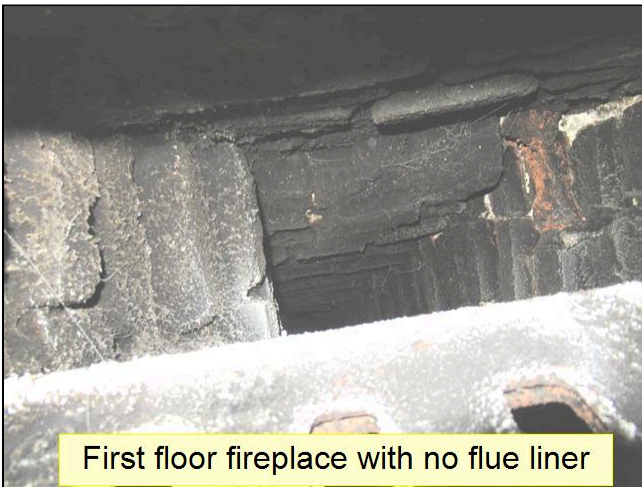
8.1 The first floor chimney appeared to be unlined. When the damper at the upstairs fireplace was opened a lot of masonry debris and soot fell down. If the fireplaces are to be used at all, I recommend that a liner be installed by a qualified chimney sweep. I also recommend the inside of both chimneys be inspected with a camera so the condition of the flues can be assessed. Recommended accreditations for chimney sweeps; CSIA Chimney Sweep Institute of America and NFI National Fire Place Institute.
